## EVALUATION OF FAULT LOCATION AND SURFACE RUPTURE HAZARD - UPDATE 5885 Carpinteria Avenue Carpinteria, California

March 22, 2021

Subject: Update of Fault Location Report 5885 Carpinteria Avenue Property (APN 01-170-13) Carpinteria, California

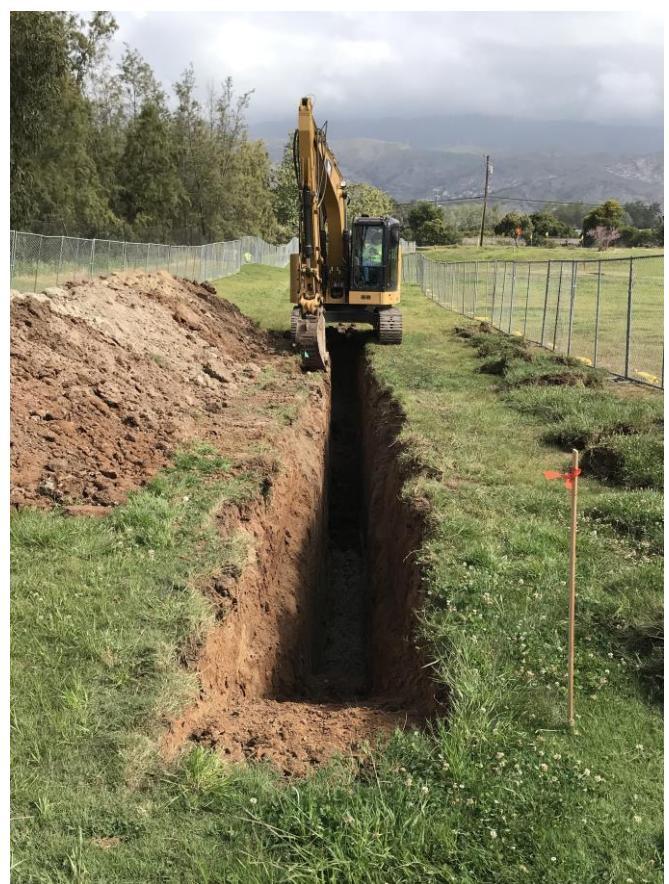
South End of Trench CG-1

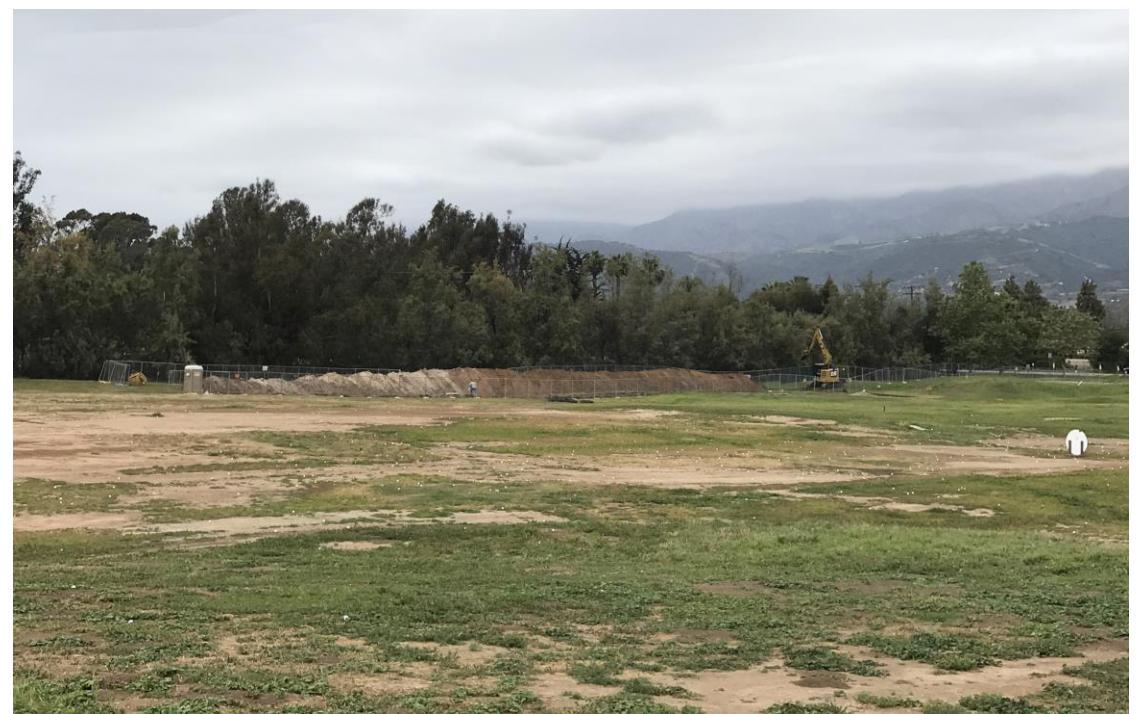
View to Northwest, Trench CG-1

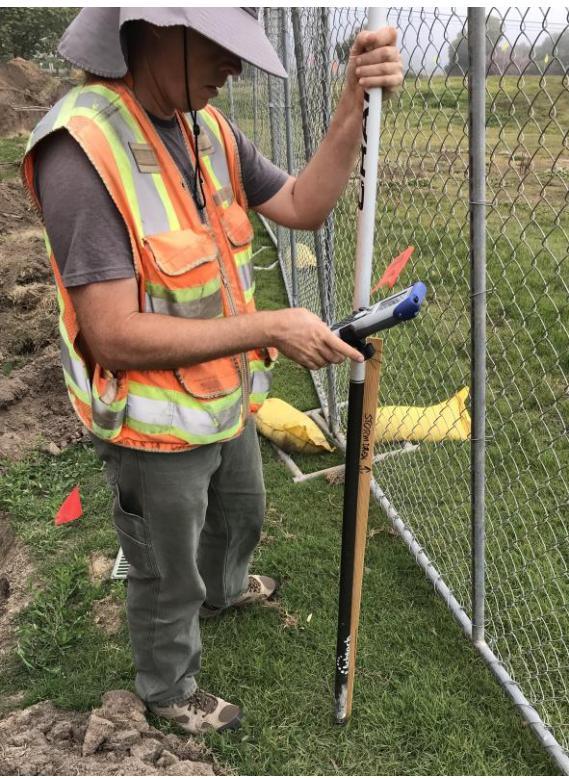
Waters Cardenas survey of trench and locations of staked features

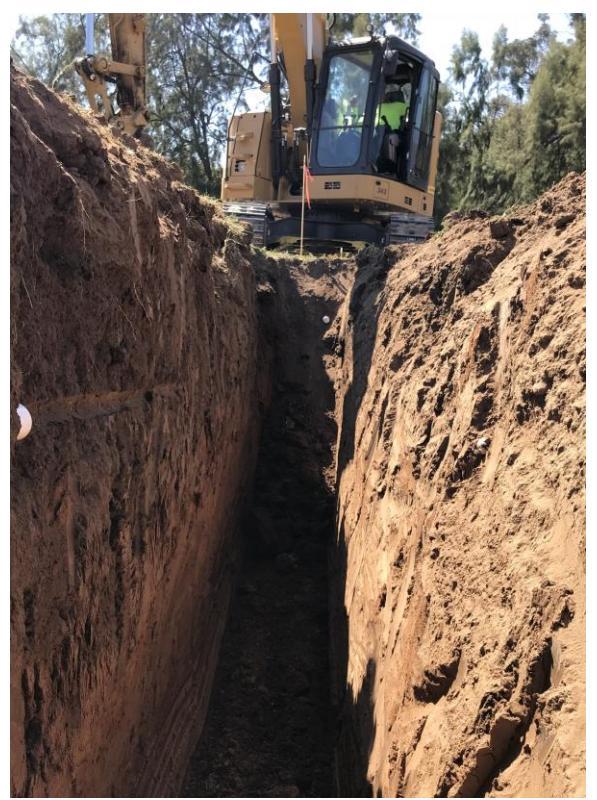
View to West, CG-Test Pit 1

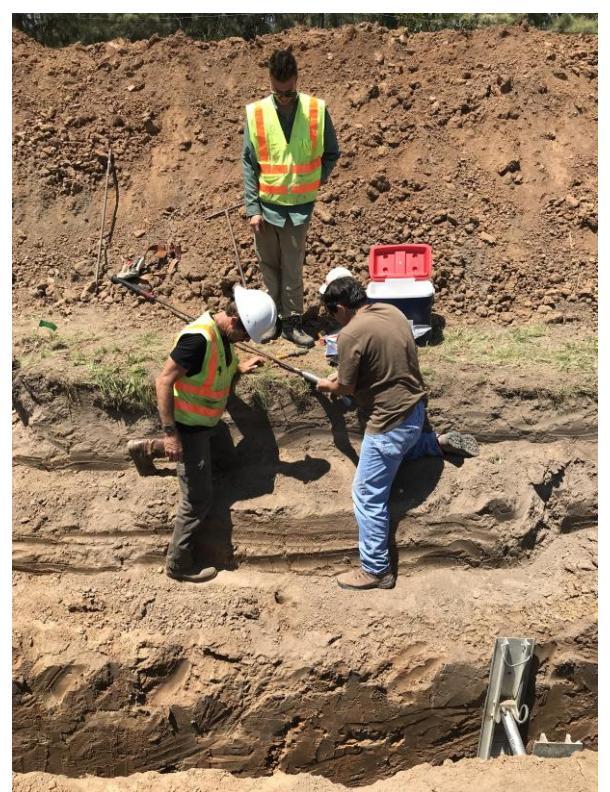
Collection of Sample for Analysis by OSL Age Dating Method

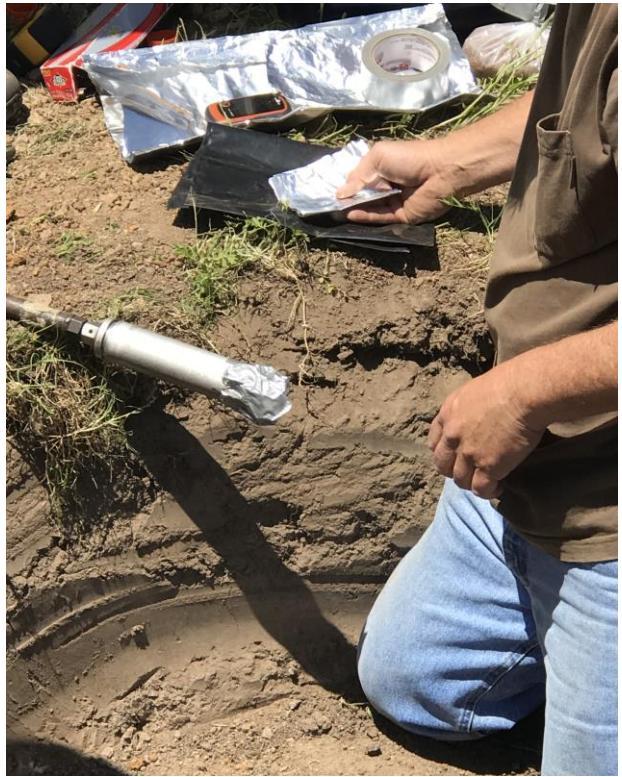
Sample Recovery and Preparation for OSL Analysis

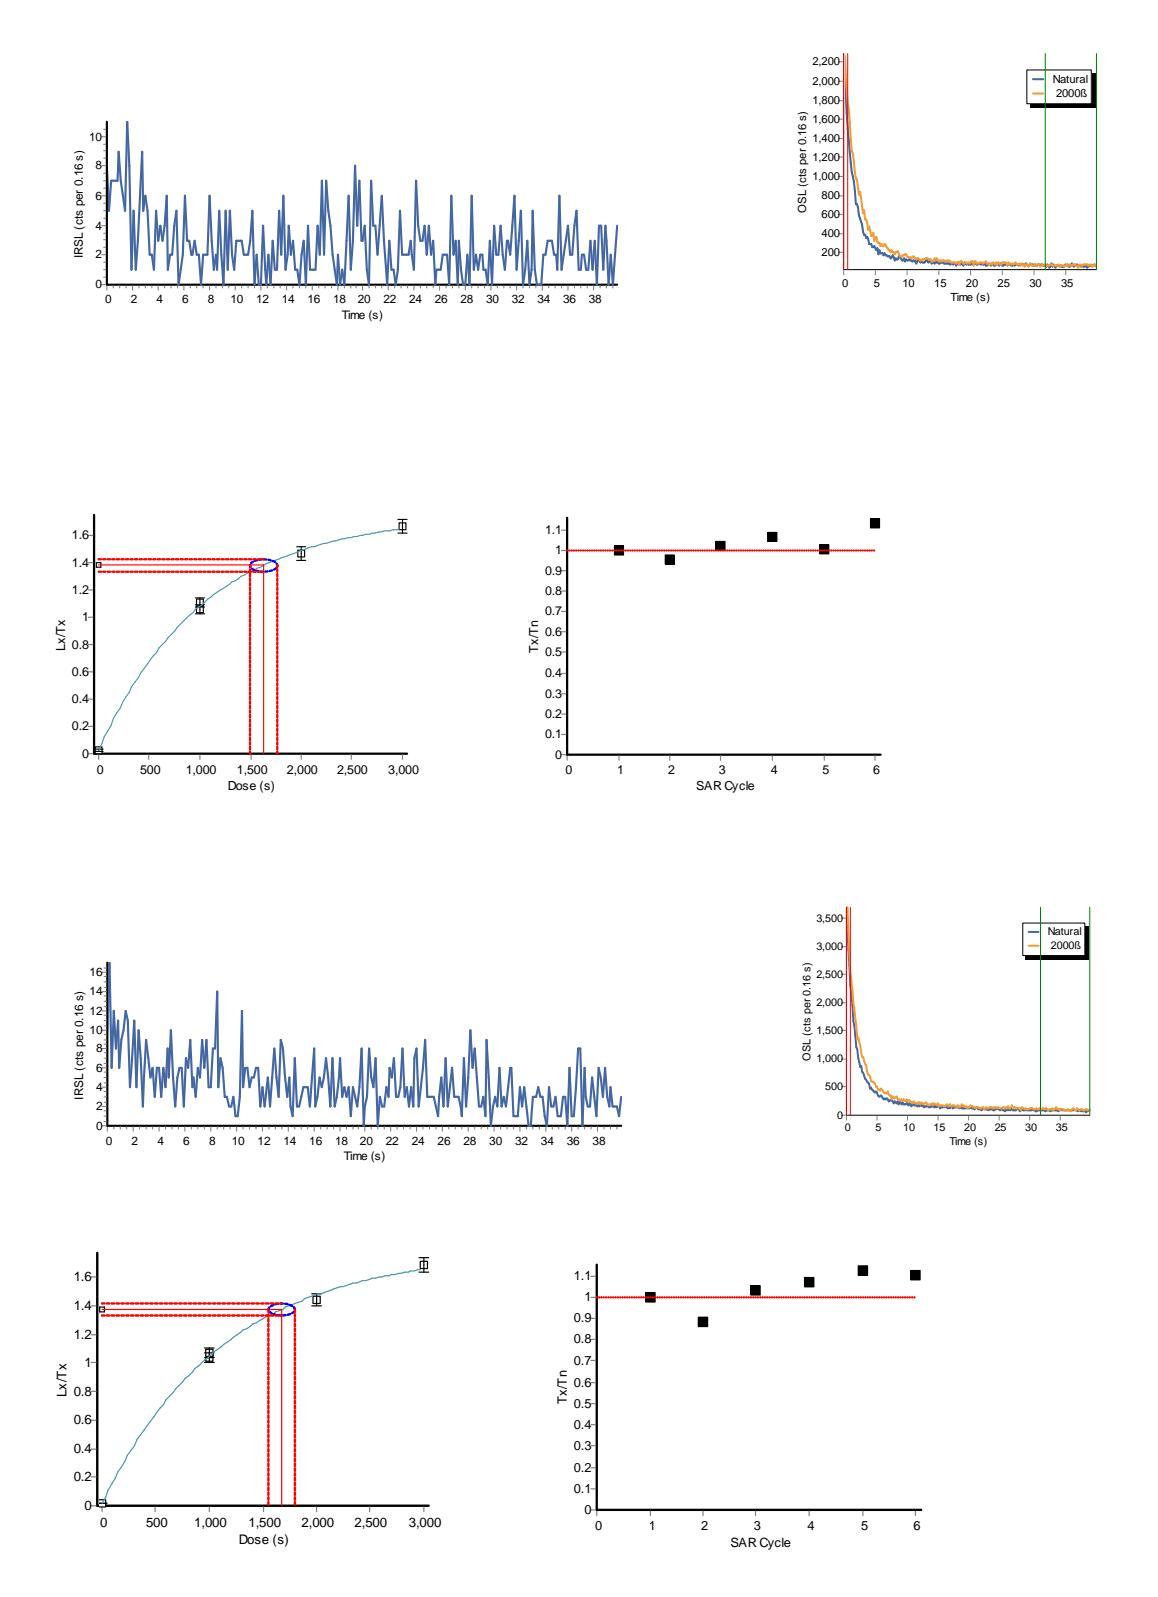
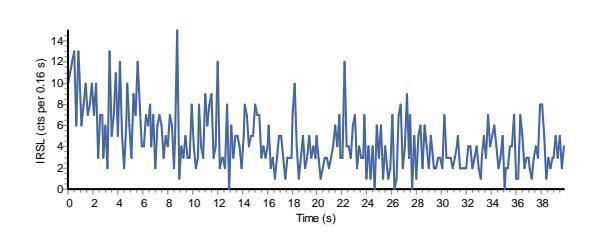
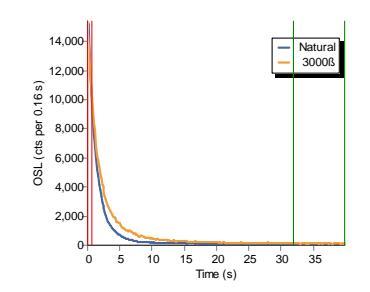
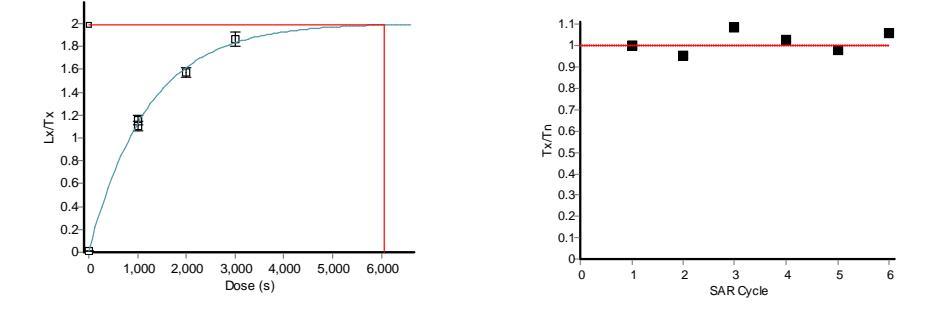
The natural OSL signal for all aliquots were at least two orders of magnitude greater than background signal. The shine down curves (luminescence stimulated in the lab over 40 s of exposure to light) for all aliquots showed fast decay patterns that confirm that the signal is the fast component of luminescence, which is dominant in quartz. This provides confidence quartz would have likely been bleached quickly if only briefly exposed to sunlight. Figure 1 shows an example of a shine down curves for the dated sample. Figure 1 also shows examples of the regenerative curves, illustrating good growth and recuperation. An example of an IRSL "shine down" curves used to test that there was no feldspar within the sample (the curves only have background signals and no shine down) are also shown in Figure 1. Dose rate recovery tests for the samples shows that they have good recovery within the uncertainty of the laboratory measurement and 10% of the applied dose of 100 s (Figure 2).

**Figure 1.** Examples of typical ISRL tests for feldspar (top left), OSL shine down curves (top right), regenerative curves (bottom left) and recycling ratio (bottom right) for three different aliquots.

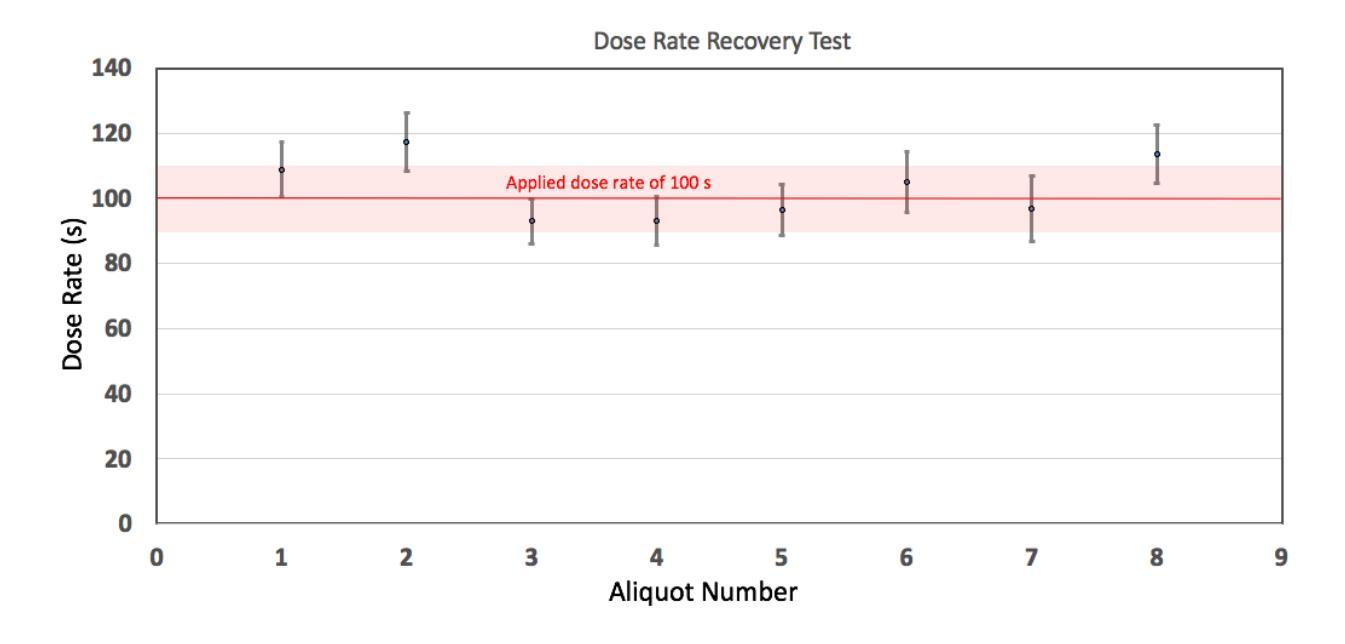
**Figure 2.** Dose rate recovery test for sample CG-1-OSL-1 using eight aliquots. The applied dose was 100 s and the pink band show 10% variance from the dose. All aliquots recover with 10% of the applied dose.

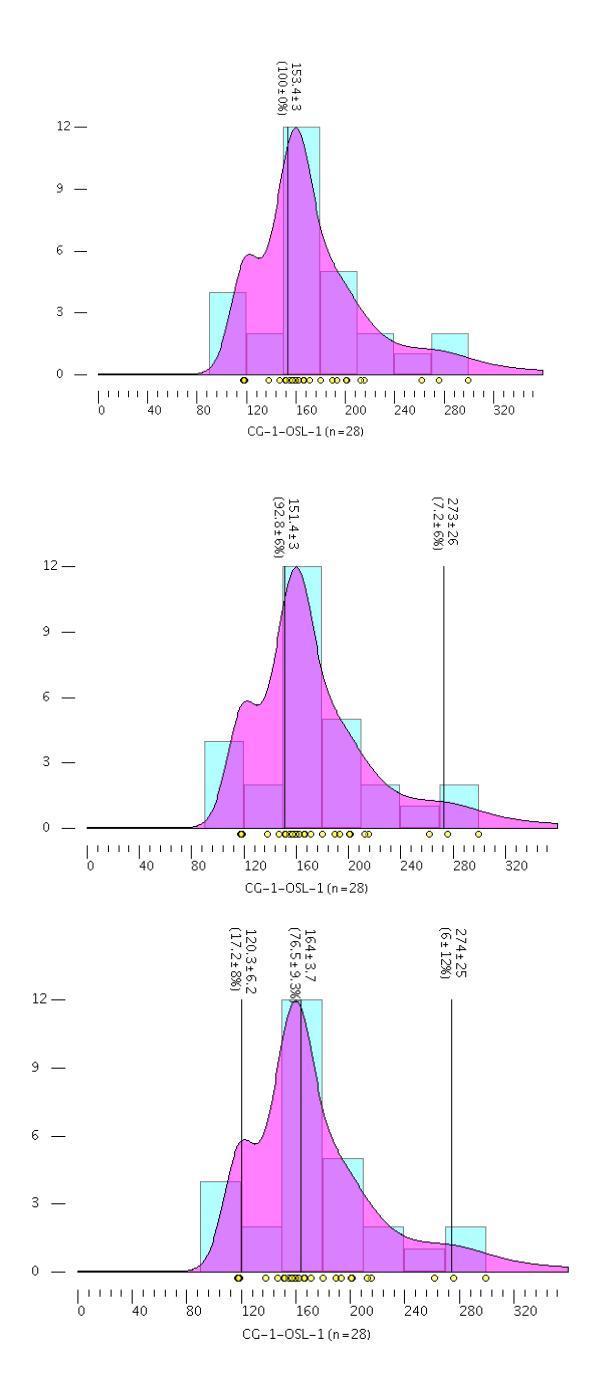
Forty-eight aliquots were measured. Of those 11 aliquots were saturated ( $\times$ 500 Gy), four ranged from 288 to 576 Gy with infinite uncertainties, and five failed the recuperation and recycling criteria. The remaining 28 aliquots were used to determining a likely DE for the sample (Figure 3). The spread of D<sub>E</sub> varied between samples and are shown in Figure 3. The large spread of D<sub>E</sub> values and the significant number of aliquots that were saturated suggests partial bleaching problems, i.e., not all the sand grains were totally rest by sunlight before burial. This can result in an overestimate of the age. To address this issue, we use a minimum age model separating the population of DE using a three-mixing model (Figure 3, lower graph), which gives mean D<sub>E</sub> value of the minimum peak of 120.3 ± 6.2 Gy (Table 1). **This provides an age of 36.6 ± 2.5 ka, which is the best estimation of the age of sample CG-1-OSL-1 given the partial bleaching issues** (see age highlighted in bold in Table 1). For completeness and comparison, single and 2 mixing models have minimum peaks yielding D<sub>E</sub> values of 153 ± 3 and 151 ± 3 Gy, respectively. This gives ages of 46.6 ± 2.3 and 46.0 ± 2.3 ka. An average and weighted mean for aliquots yields D<sub>E</sub> values of 176.3 ± 8.6 and 120.3 ± 2.6 Gy, respectively (Table 1). These give ages of 53.6 ± 2.7 and 46.6 ± 2.3 ka (Table 1). These ages are likely too old given partial bleaching issues.

**Figure 3.** Equivalent doses for sample CG-1-OSL-1, plotted as histograms (number of aliquots) and probability against equivalent dose (Gy) for single (upper), two (middle) and three mixing (lower) models.
