# City of Carpinteria

## Environmental Review & Monitoring

### Status Report 2023

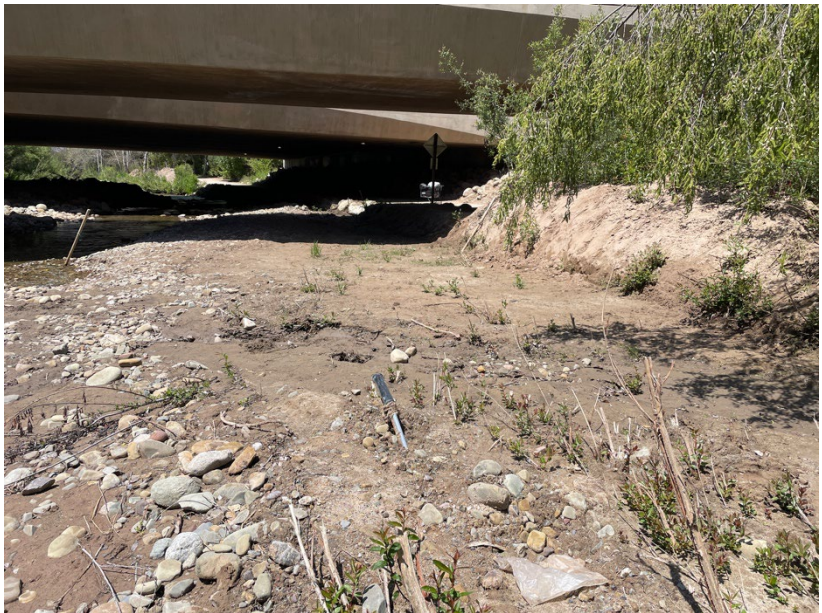
The high creek flows in early 2023 caused a number of problems at the Highway 101 overpass. All of the plantings in the creek channel were washed out and most of the willow cuttings under the overpass are gone. A lot of the irrigation sprinklers and piping within and along the creek channel were also damaged or destroyed (Photo 1). Some of the piping was washed downstream.

***Photo 1. Irrigation materials within Carpinteria Creek***

In the 2022 status report for the City of Carpinteria, a recommendation was made to remove the irrigation systems in case they were “washed away by high flows”. This has now happened, and the remaining irrigation equipment should be removed.

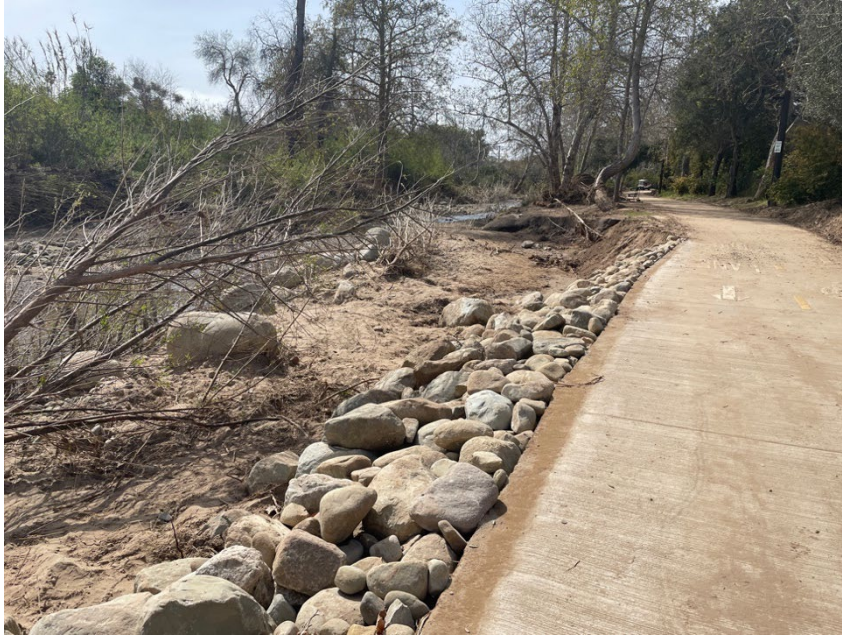
The high water also washed away a portion of the western creek bank, just downstream of the Highway 101 overpass (Photo 2). Later in the year dirt and riprap rock was brought in to restore the

creek bank. In previous discussions and emails, the City Biologist had suggested that the willow berm installed after the overpass construction, would redirect high flows toward the west bank. The berm angles out into the creek channel from the southeastern corner of the overpass thereby constricting the flow and forcing it toward the west bank (Photo 3). No explanation was ever given as to why this feature was installed but it will be an ongoing problem.

***Photo 2. Washed out portion of the creek bank along the bike path***

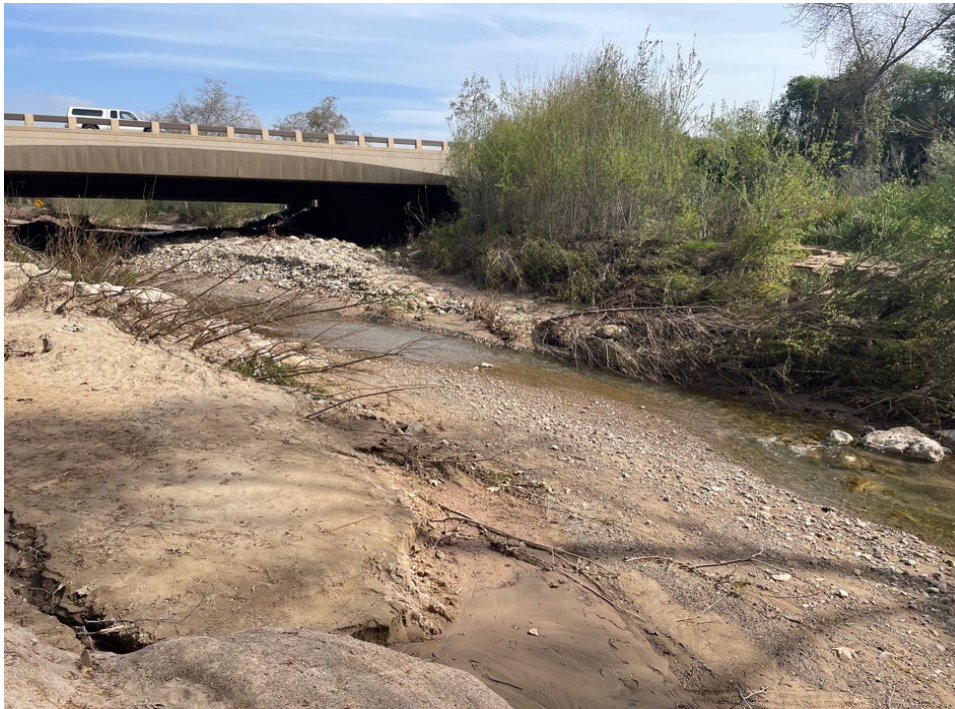
***Photo 3. Willow berm extending out from the southeastern corner of the Highway 101 overpass***

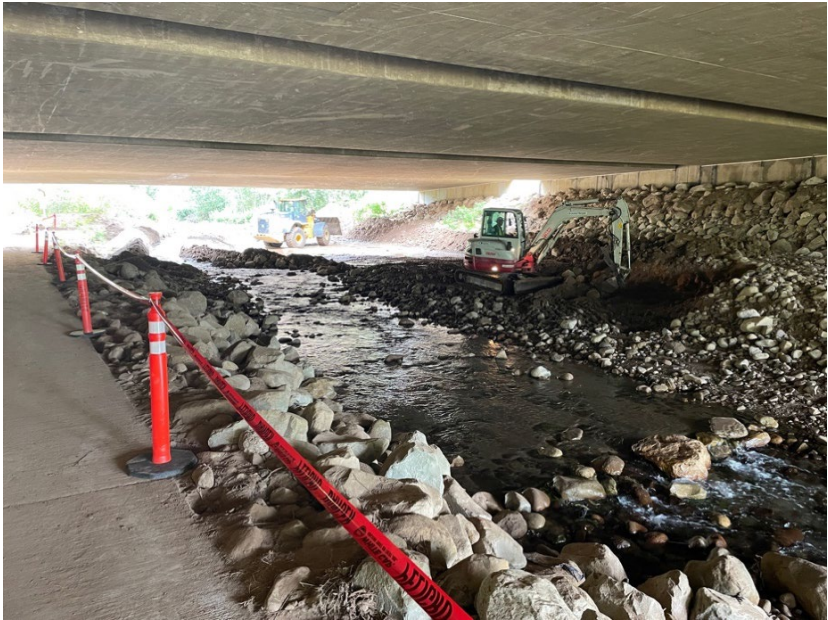
Lastly, the high flows deposited a large amount of sediment (i.e. rock and dirt) under the overpass. This material was dug out in June of 2023 (Photo 4). The City Biologist and City staff were not notified of this work. The City Biologist checked in with the crew removing the dirt; noting they were parking trucks in Environmentally Sensitive Habitat and under the dripline of native trees (Photo 5). They were asked to relocate their vehicles.

***Photo 4. Removal of excess material under the highway overpass***

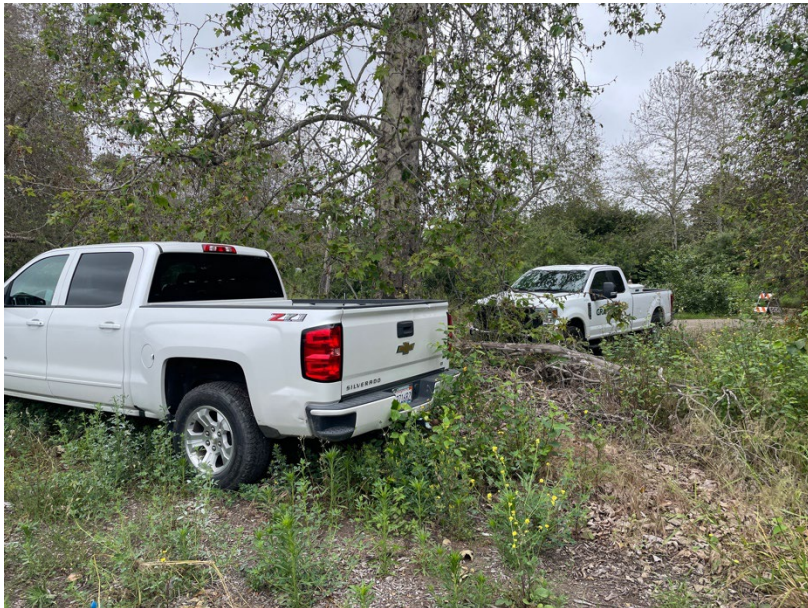
***Photo 5. Vehicles parked in Environmentally Sensitive Habitat***

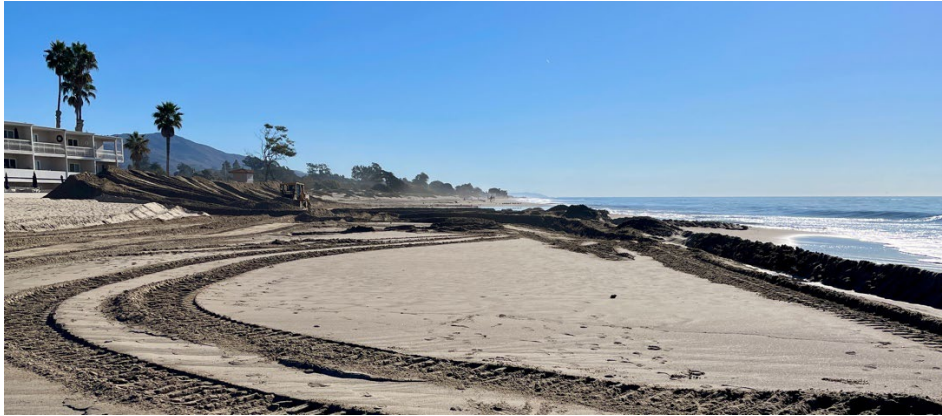
For various reasons the spring berm removal was delayed, requiring grunion surveys before the work could proceed. City personnel and the City Biologist spent three nights monitoring for a possible grunion run. During the second night approximately 20 grunion were seen coming up on the beach, but no large “run” was observed and no egg laying. Without a grunion run, the berm work could proceed (Photo 6).

***Photo 6. Sand berm work at the City Beach***

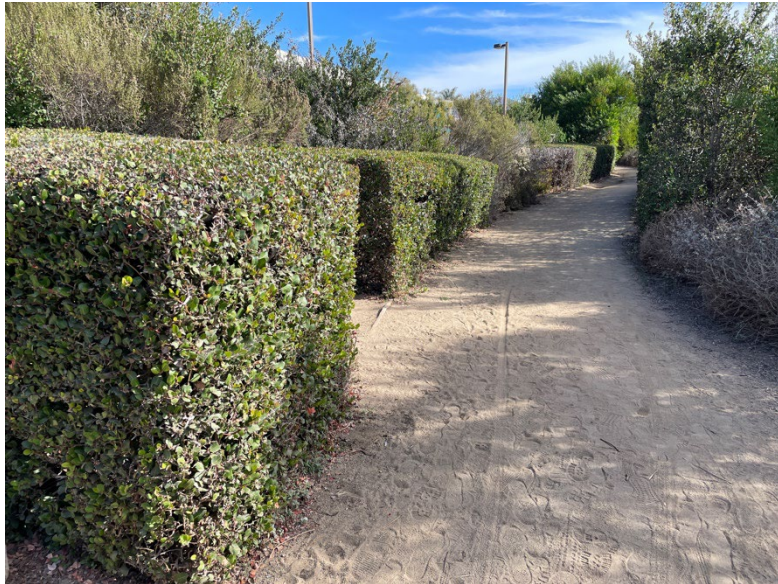
Portions of the Bluff Trail were built and revegetated as mitigation measures for the various developments on the bluffs. Some patches of iceplant remain along the trail, removal would benefit the native habitat. The landscape crews continue to prune the native vegetation along the trail (Photo 7). Contact should be made with the respective property owners/managers to address the landscape pruning within the mitigation areas.

***Photo 7. Pruning of native vegetation***

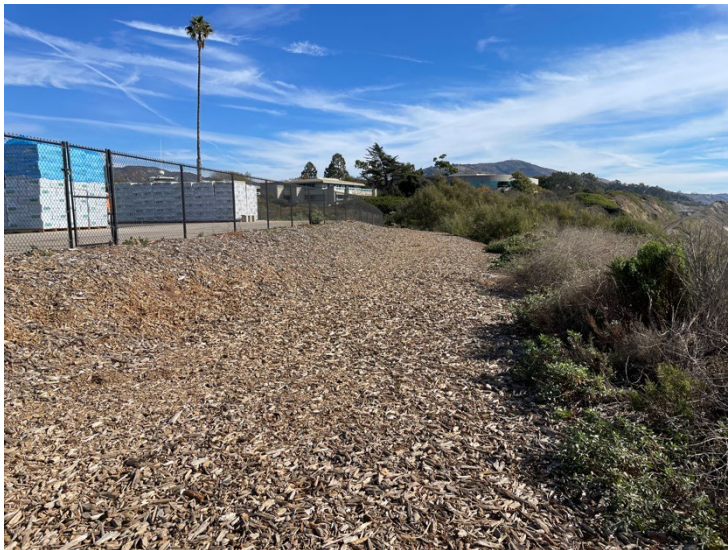
What looks to be a new section of the bluff trail has been cleared around the S&S Seed facility (Photo 8). The City Biologist was not notified of this work. Quite a bit of vegetation was removed and chipped up in preparation for establishing this portion of the trail.

***Photo 8. Vegetation clearing for a new portion of the Bluff trail***

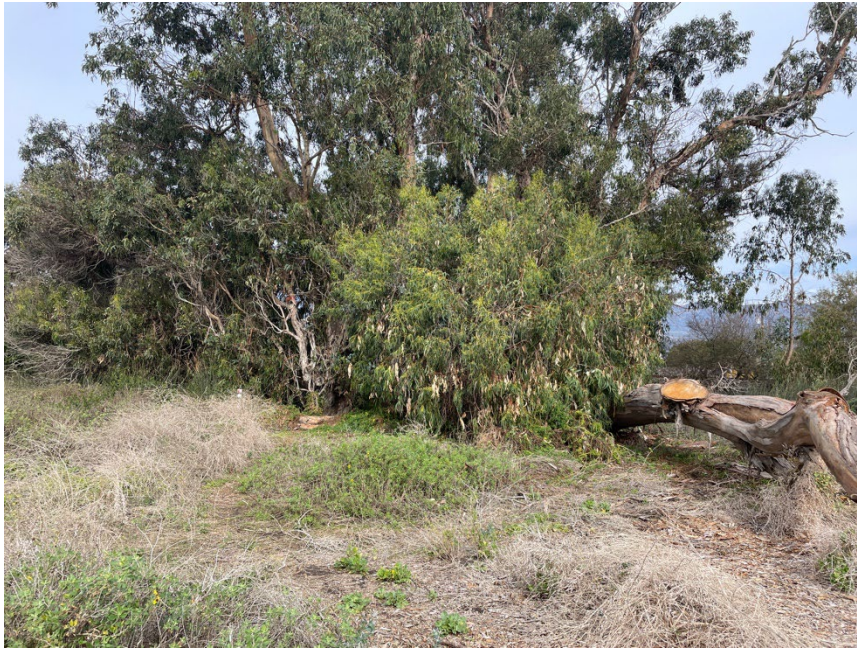
***Photo 9. Eucalyptus windrow***

The Carpinteria Bluffs Preserve is a beautiful and well-used preserve. Some grassland restoration continues by the local community. Tamarisk (salt cedar) remains in the northwestern corner of the property and should be removed. Some thinning of seedlings and removal of the dead and downed branches should be considered for the eucalyptus windrows (Photo 9).

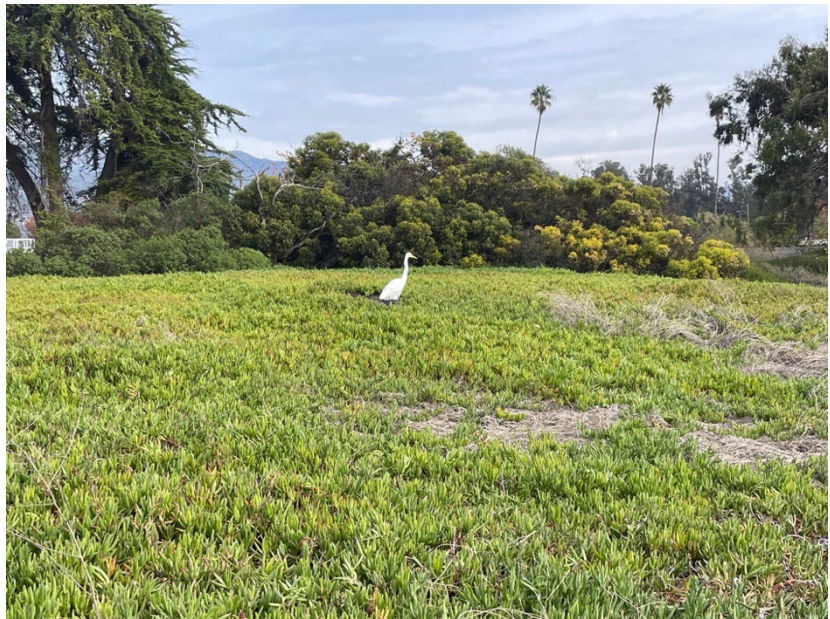
***Photo 10. Iceplant within Tar Pits Park***

A recommendation for park improvements would be to close off and reroute the portion of the bluff trail away from the small riparian corridor. This area regularly floods and if left alone it would create some excellent habitat for plants and animals. Some pruning and thinning of the eucalyptus and eradication of mustard and iceplant are also recommended (Photo 10).

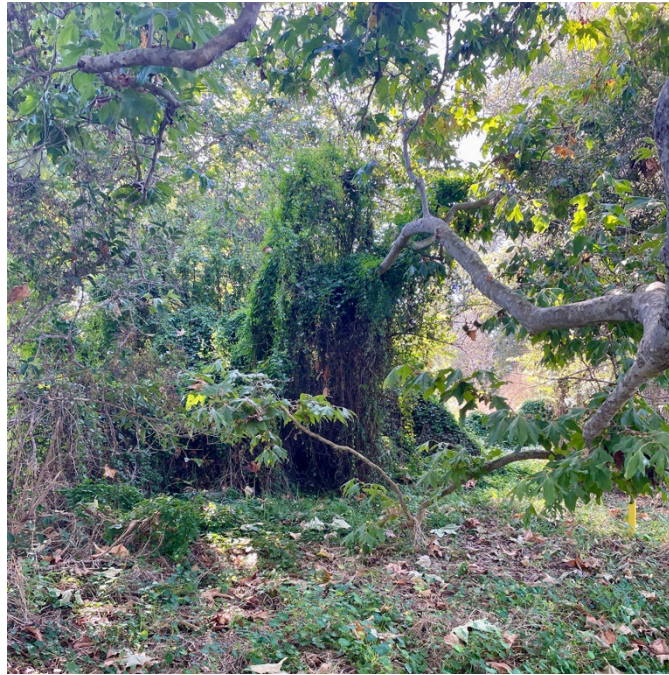
***Photo 11. Cape Ivy near the Creek Park***

The Carpinteria Creek Park remains in good shape and looks to be well-maintained by the City's landscaping crews. The riparian corridor to the west of the park would benefit from an enhancement plan, with attention to removing the cape ivy (Photo 11).

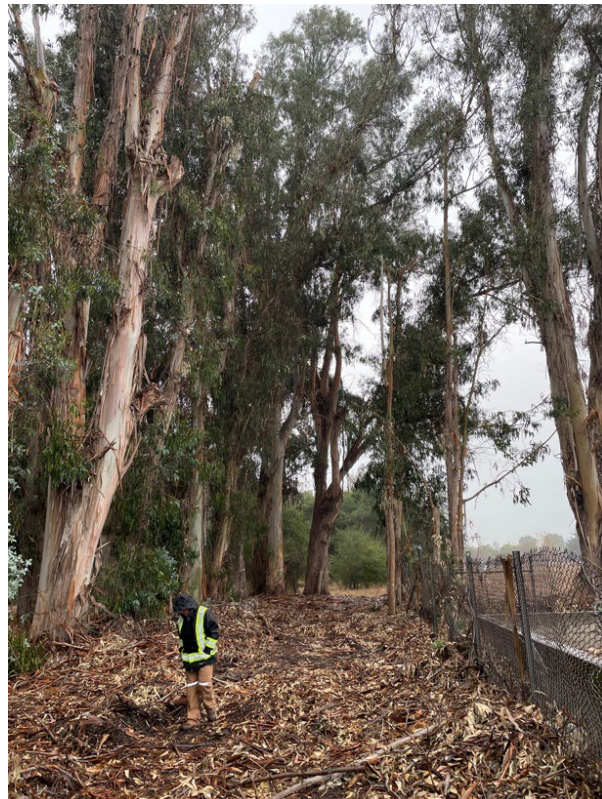
The 22/23 winter roost site had been damaged by some tree trimming work (Photo 12). Some consideration should be given to the Monarch winter roost when planning a tree trimming operation.

***Photo 12. Winter Monarch roost site damaged by tree pruning***

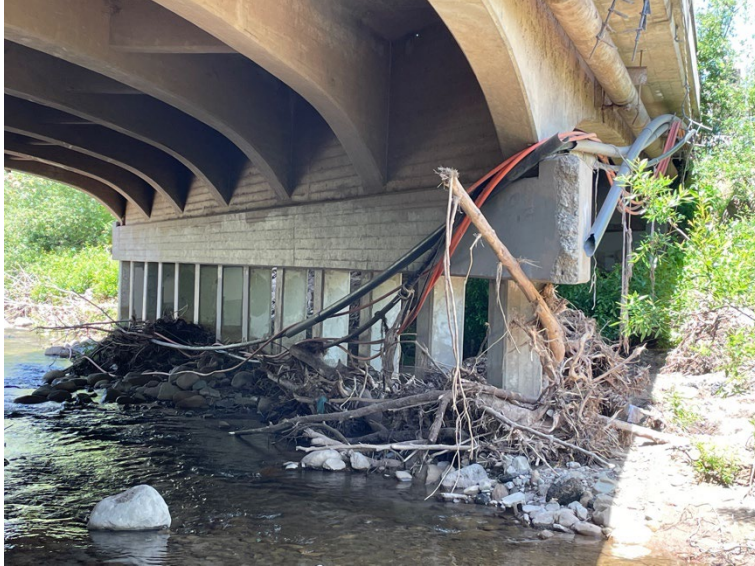
In early 2023, the Carpinteria watersheds were subjected to a number of atmospheric river storm events resulting in some very high water in our local creeks. Carpinteria Creek was running high enough to reach the underside of the Carpinteria Ave. bridge. Lots of fencing, cable, conduit, and other debris ended up in the creek (Photo 13). Over the course of the year a lot of this material was

***Photo 13. Carpinteria Ave bridge***

eventually removed. The City Biologist did some trash removal in this area.

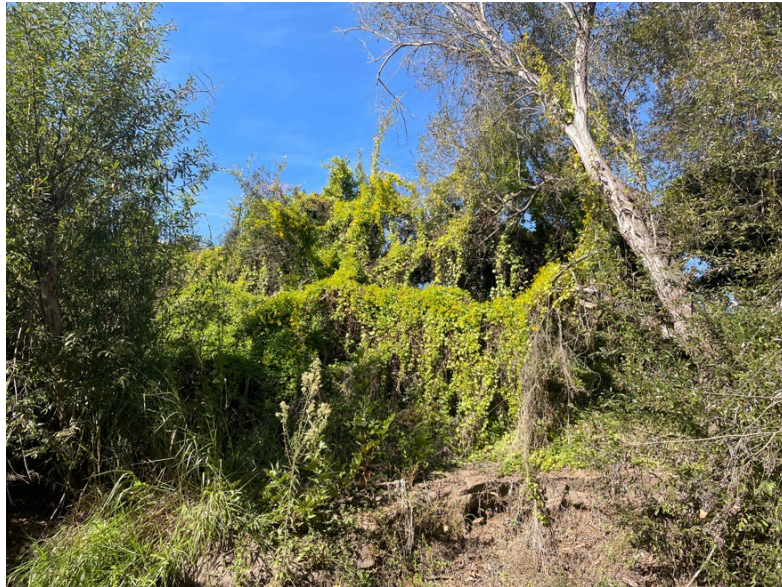
Portions of the Carpinteria Creek riparian corridor are overrun with Cape Ivy (Photo 14). Some level of eradication would greatly benefit the overall health of the creek corridor.

***Photo 14. Cape Ivy along Carpinteria Creek***

Eradication of Cape Ivy along both Carpinteria Creek and Lagunitas Creek would benefit the native flora and fauna.

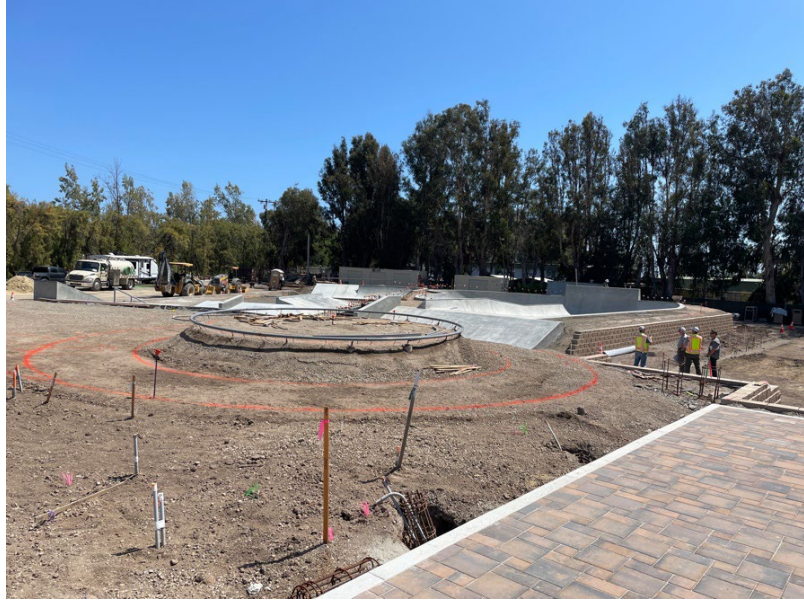
Work continued on the new skate park location next to the City Hall offices (Photo 15). It was completed and opened in 2023.

***Photo15. Construction of the new skate park***

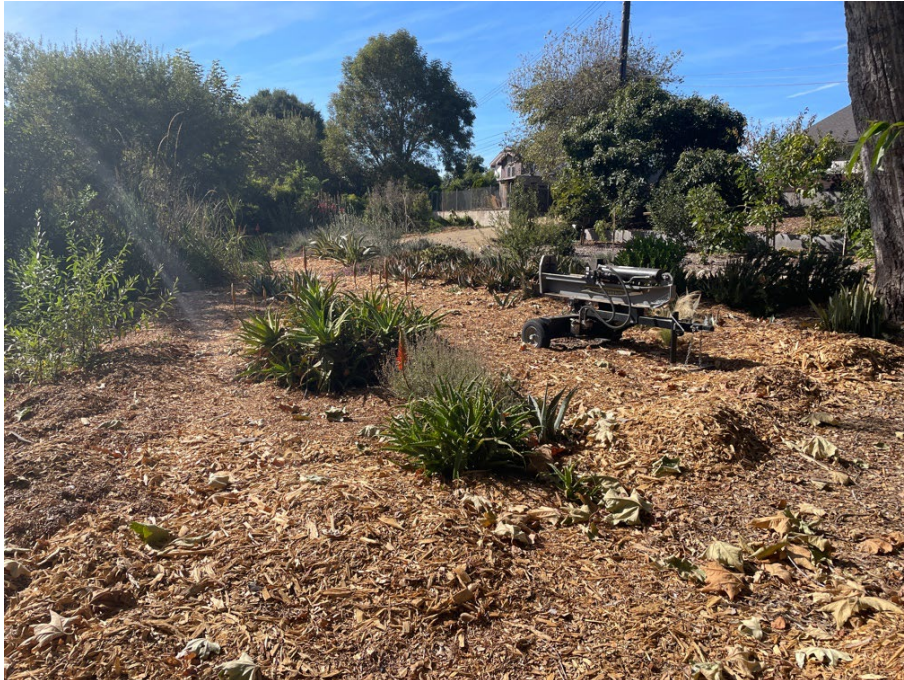
***Photo 16. Riparian corridor adjacent to 1274 La Brea Lane***

The City Biologist again checked on the landscape encroachment into the riparian corridor adjacent to the property at 1274 La Brea Lane. The homeowners continue to expand their landscaping into the natural area and have upgraded the roadway (Photo 16). The SB County Flood Control District is aware of the situation and may eventually restore this area to its more natural state.

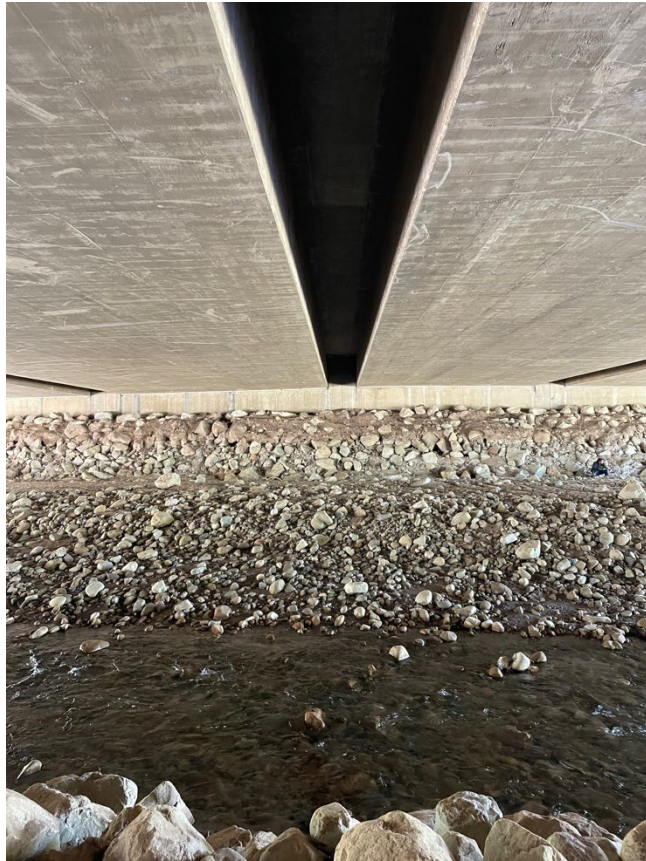
***Photo 17. Gaps under the Hwy 101 underpass***

Placement of bat boxes are recommended for installation under the Highway 101 bridge. They would fit nicely in the gaps between the concrete reaches (Photo 17). Some consideration should also be given to incorporating bat roosts into the design of the new Carpinteria Ave. bridge.
