Chevron Carpinteria Oil and Gas Facility Decommissioning Project

List of Appendices

Appendix A – Project Design Information

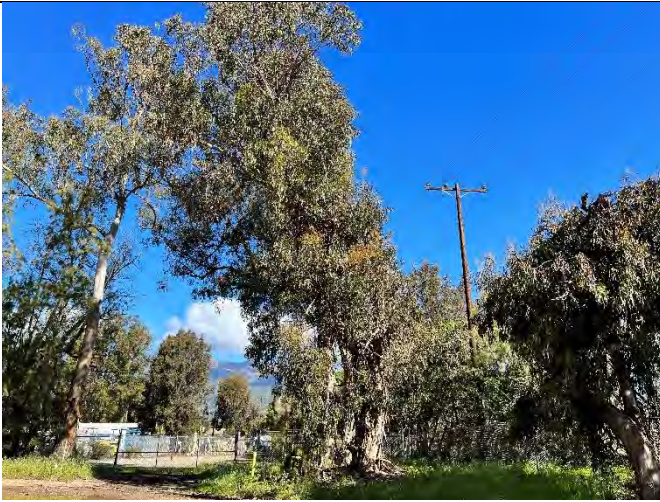
Photo 5. View to the north of Area #5, showing trees in proximity to high voltage cables. March 7, 2023

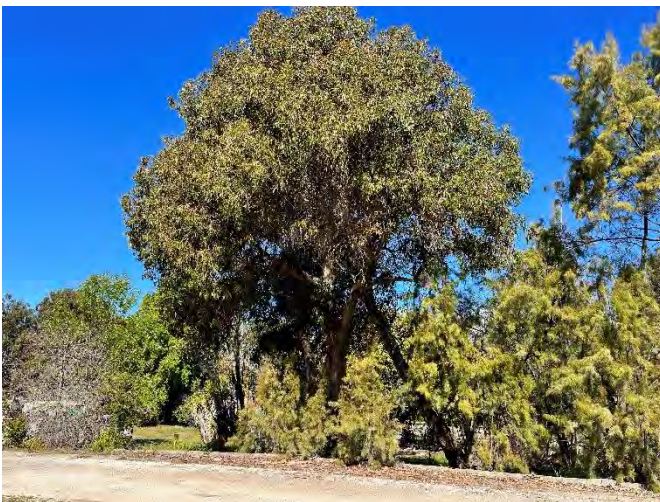
Photo 7. View to the northwest of Area #7, showing large eucalyptus with tamarisk proposed for removal leaning onto it. March 3, 2023

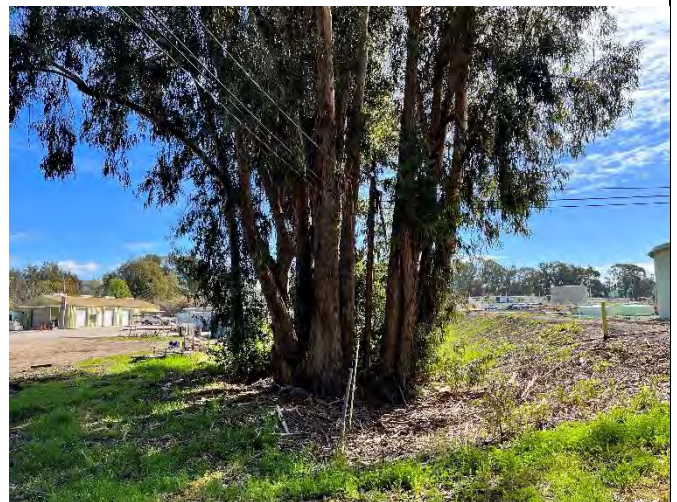
Photo 8. View to the east of Area #8, showing dense stand of eucalyptus surrounding communications pole. March 6, 2023

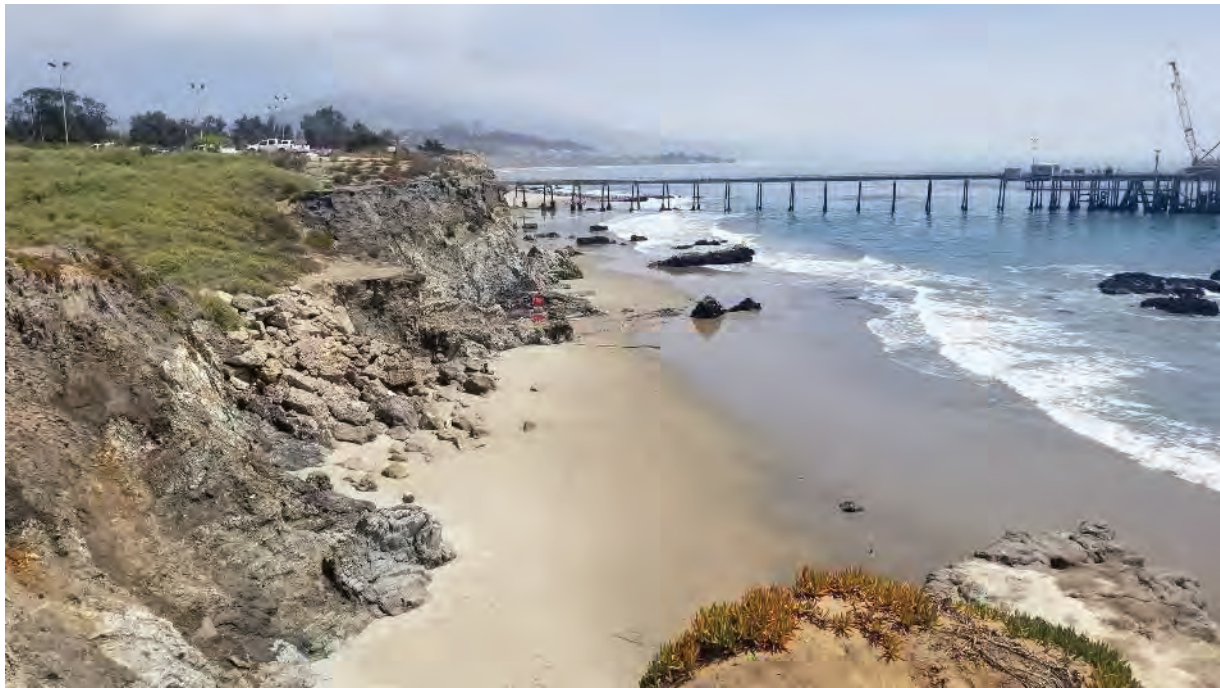
Photo 1. Study area on west side of Casitas Pier and Marketing and Marine Terminal Offloading line bundle (buried). Date: April 20, 2021, aspect east.

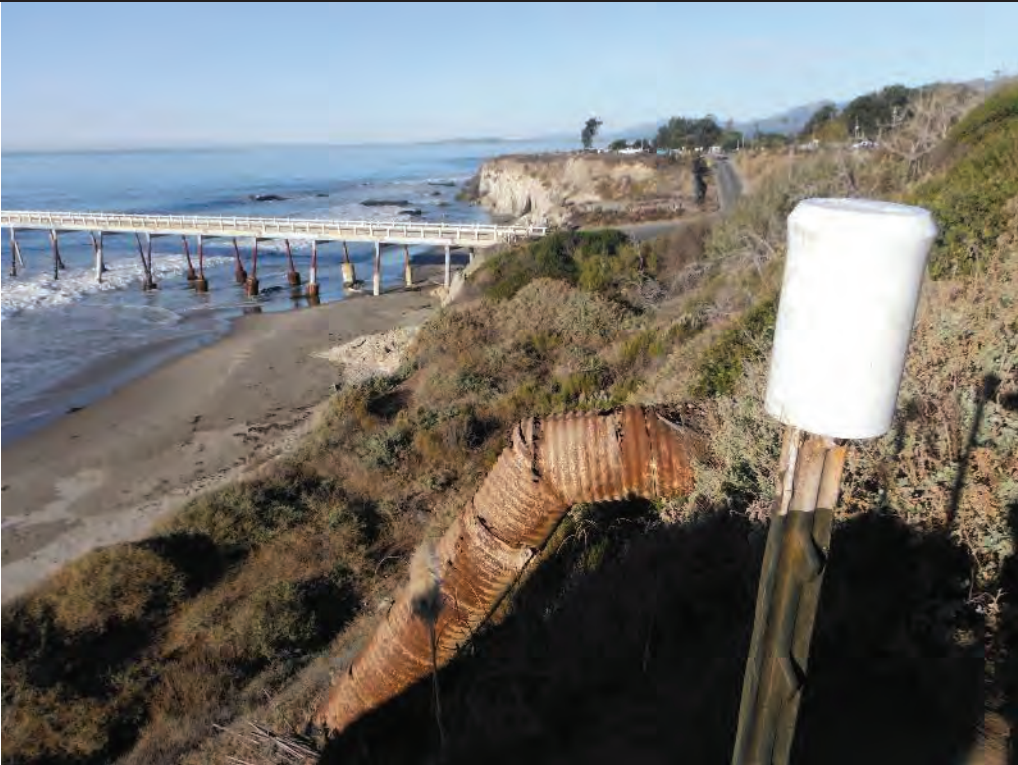
Photo 2. Study area on east side of Casitas Pier with Gail and Grace pipeline bundle (buried) and exposed concrete armament. Date: April 20, 2021, aspect west.

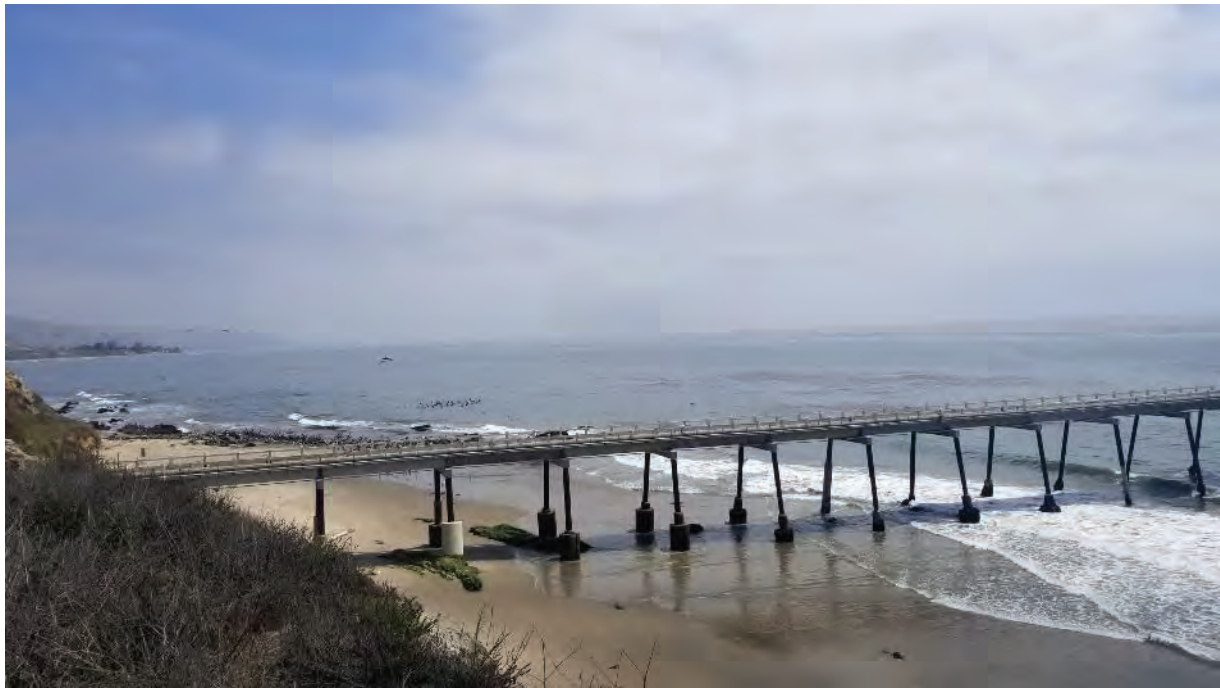
Photo 3. Casitas Pier and overview of harbor seal rookery on the east side of the Pier. Date: April 20, 2021, aspect southeast.

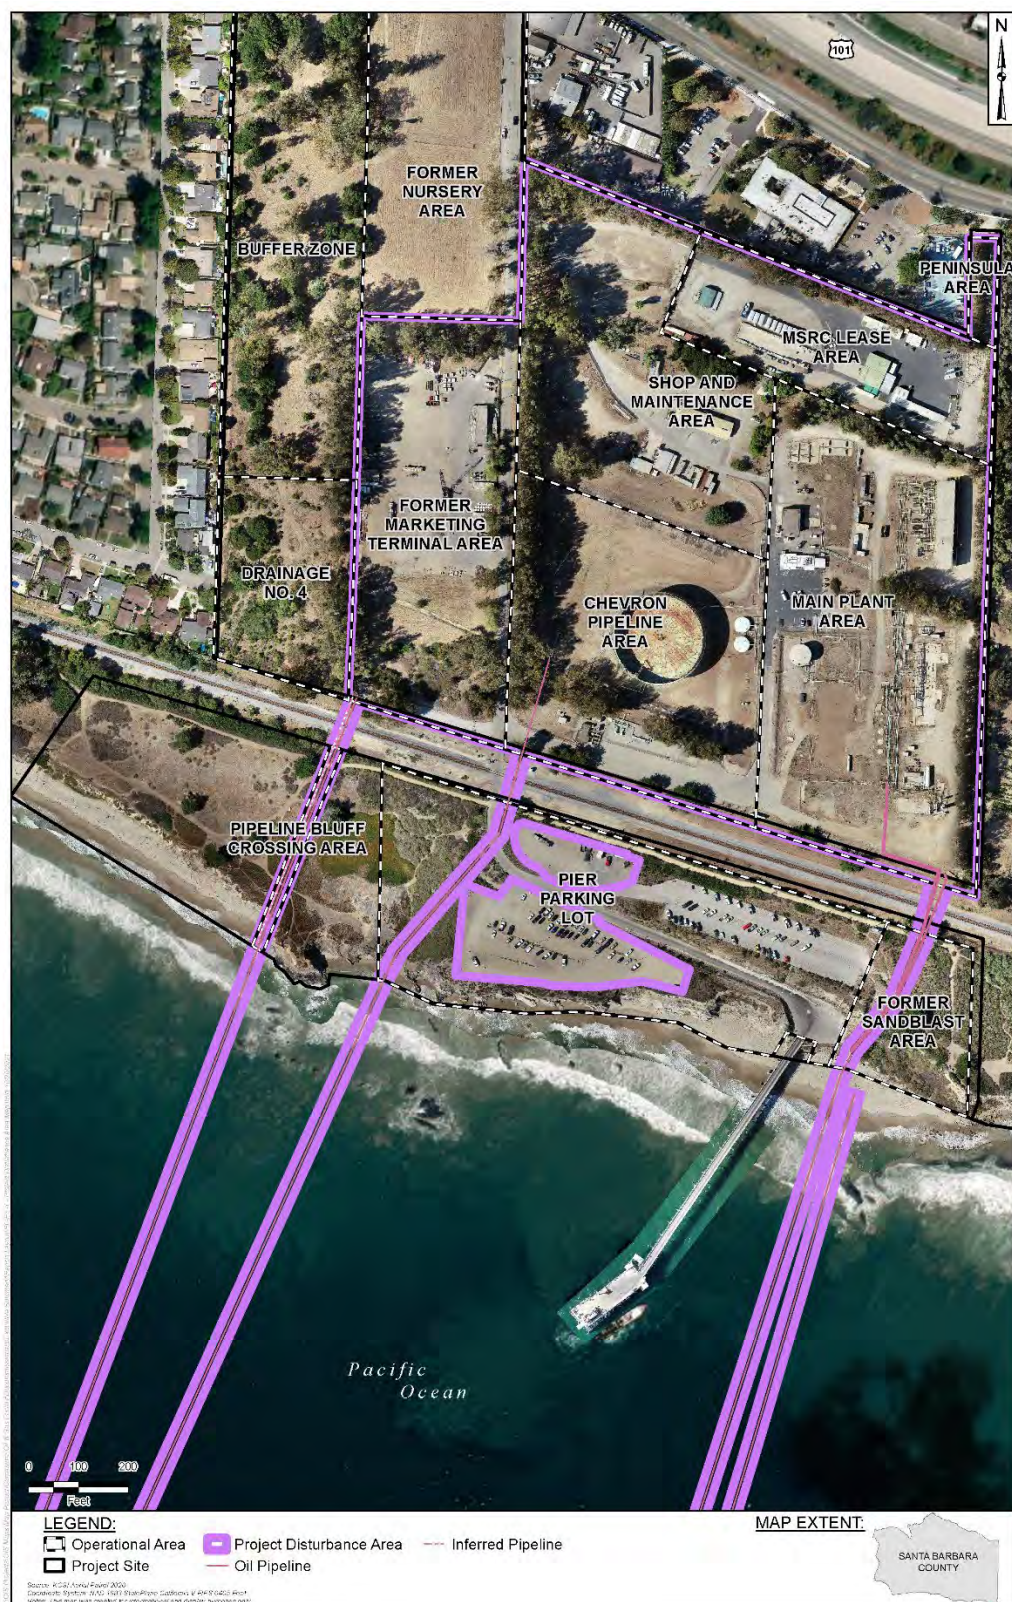
Figure 1-1. Project Location

The onshore Project Site is located in the eastern portion of the City of Carpinteria, California, between U.S. Highway 101 and the Pacific Ocean (Figure 1-1). The onshore Project Site does not support any aquatic habitats. The offshore components of the Project site are located in the adjacent nearshore waters out to the State water limits (three nautical miles) in water depths from zero to 148 feet (45 meters).

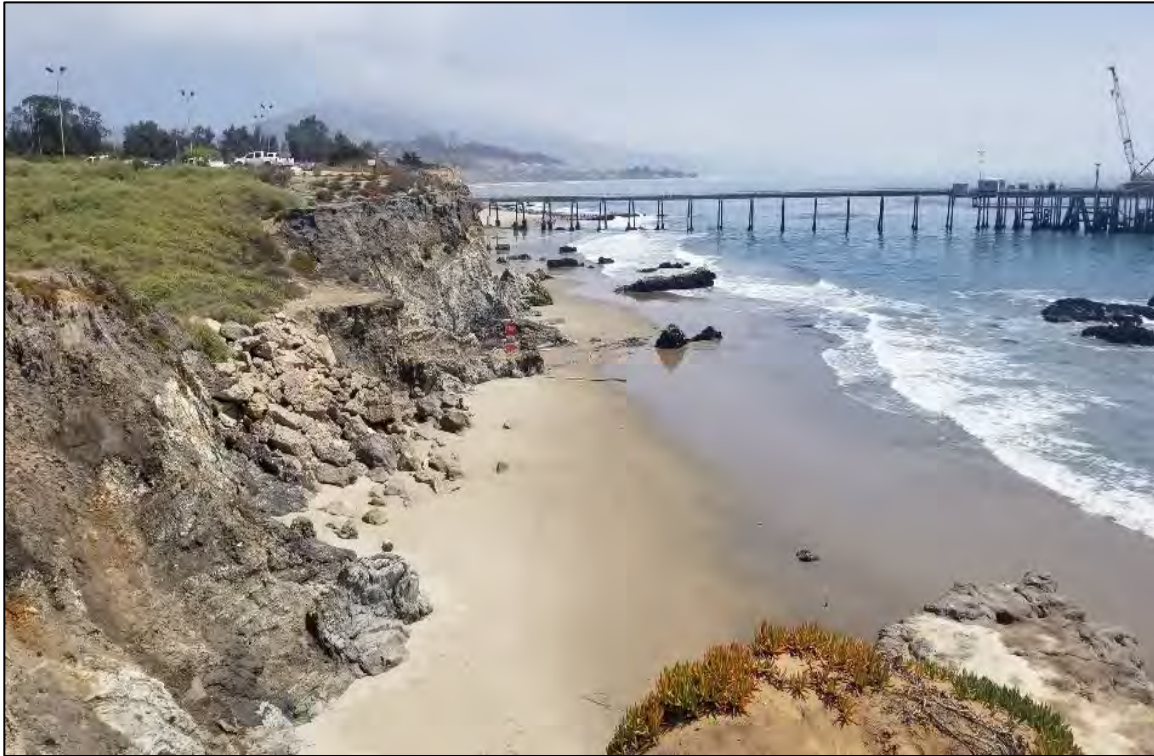
Photo 1. West side of Casitas Pier and Marketing and Marine Terminal pipeline bundle area (buried). Date: April 20, 2021, aspect east.

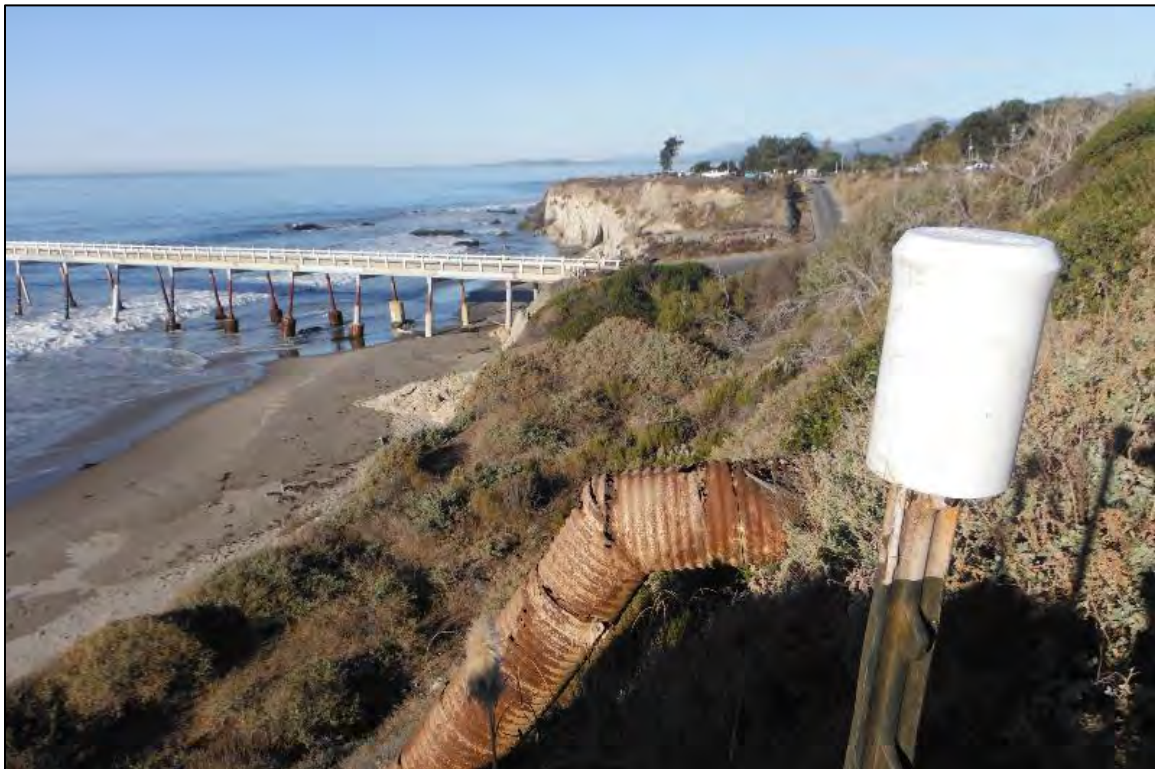
Photo 2. East side of Casitas Pier with Gail and Grace pipeline bundle (buried) and exposed concrete armament. Date: April 20, 2021, aspect west.

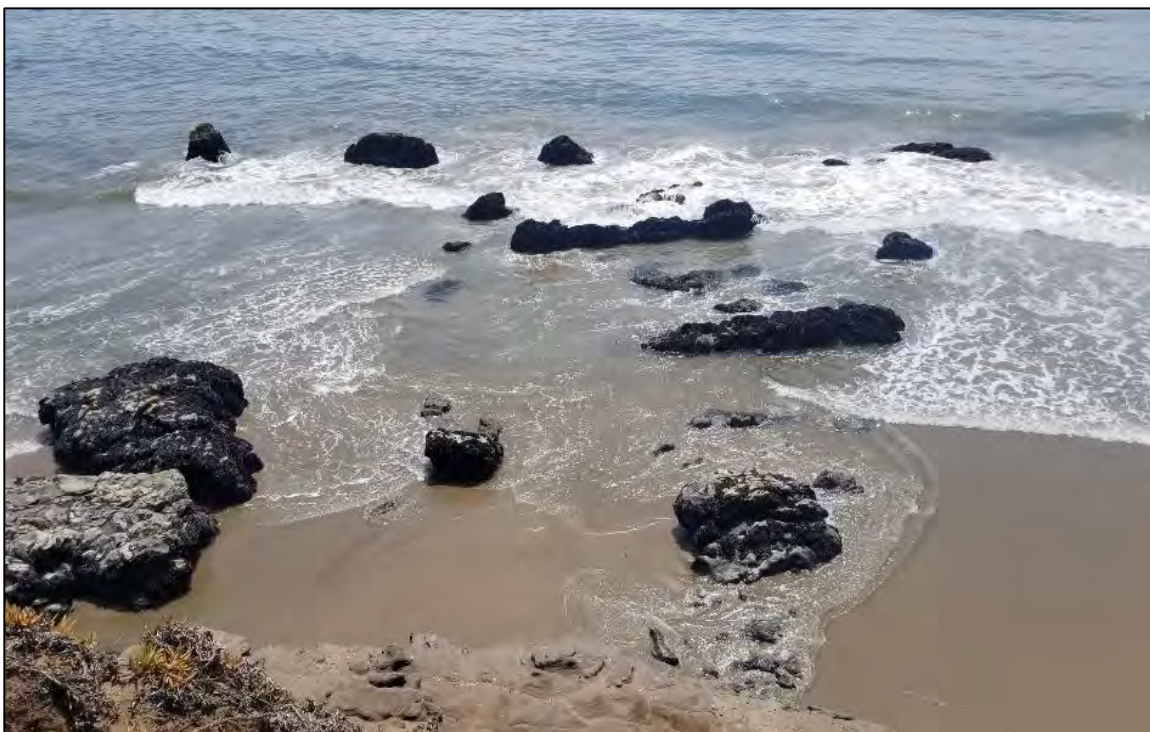
Photo 3. Overview of typical intertidal habitat dominated by mussels (*Mytilus* sp.) within original Marine Biological Resources Study area. Marketing and Marine Terminal Offloading Line Bundle out of frame (buried) to the west of the rock outcroppings. Date: April 20, 2021, aspect south.

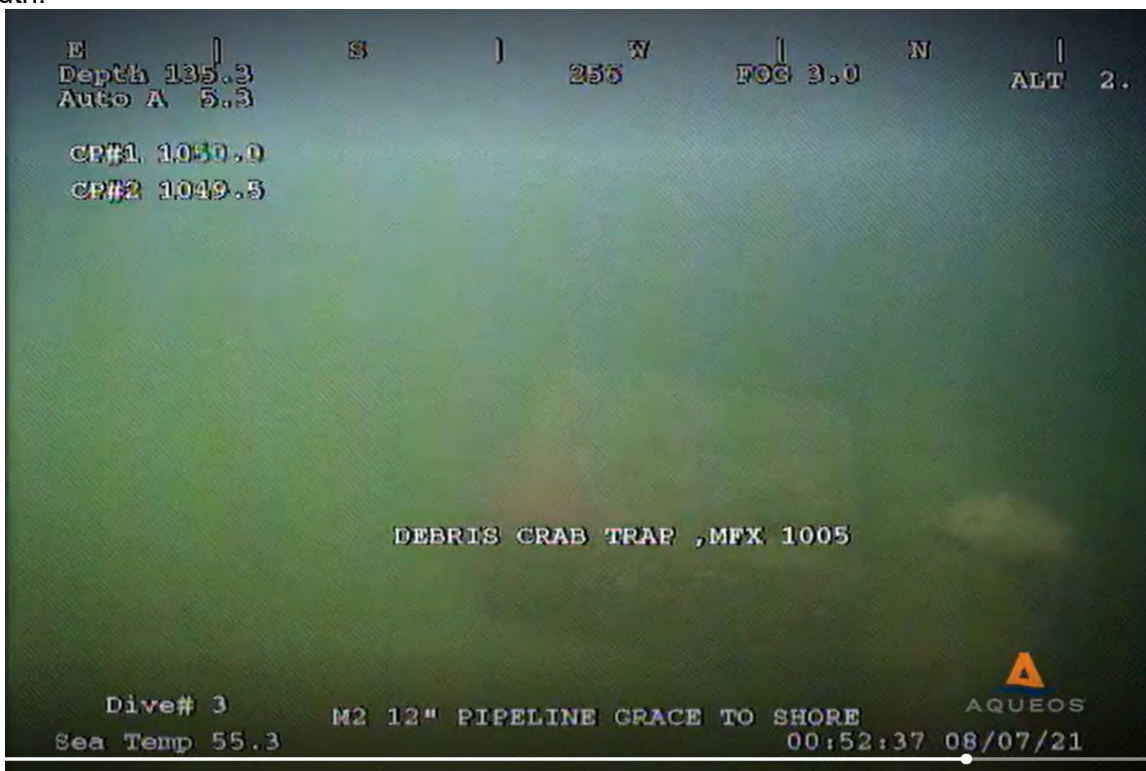
Photo 4. Imagery from 2021 Aqueos ROV survey. Debris crab trap noted adjacent exposed pipeline near State Waters boundary.

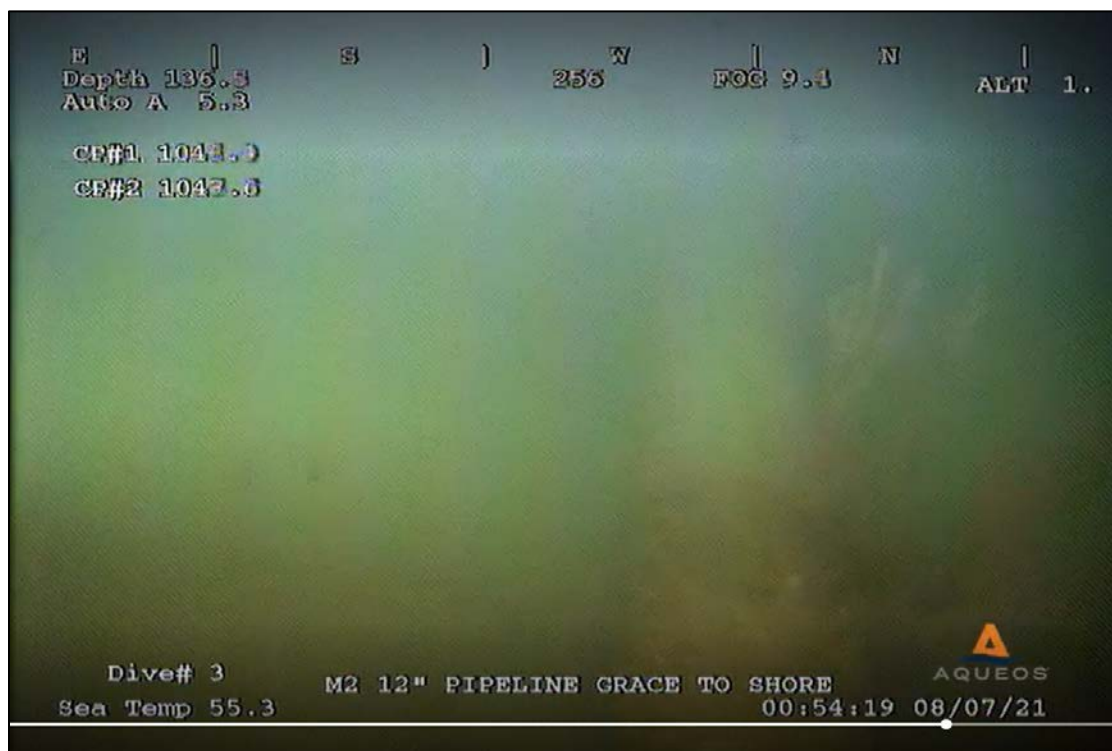
Photo 5. Imagery from 2021 Aqueos ROV survey. Exposed pipeline with minimal marine growth.
