# **BLUFF RETREAT EVALUATION REPORT**

# DECOMMISSIONING AND REMEDIATION OF THE CARPINTERIA OIL AND GAS PROCESSING FACILITIES CARPINTERIA, SANTA BARBARA COUNTY, CALIFORNIA

Project No. 2002-5211

**JUNE 2021**

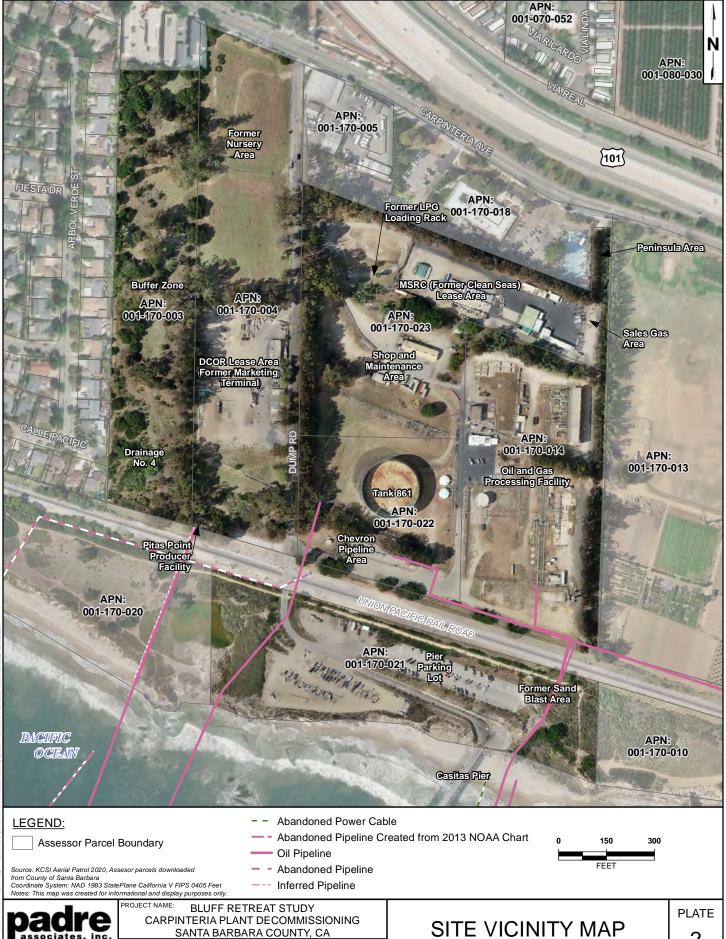
The following Bluff Retreat Evaluation Study has been prepared in support of the proposed pipeline removal located within the coastal bluff area of the Chevron Oil and Gas Processing Facility (OGPF), 5675 Carpinteria Avenue, Carpinteria, Santa Barbara County, California (Project Site). The Project location is shown on Plate 1 - Site Location Map.

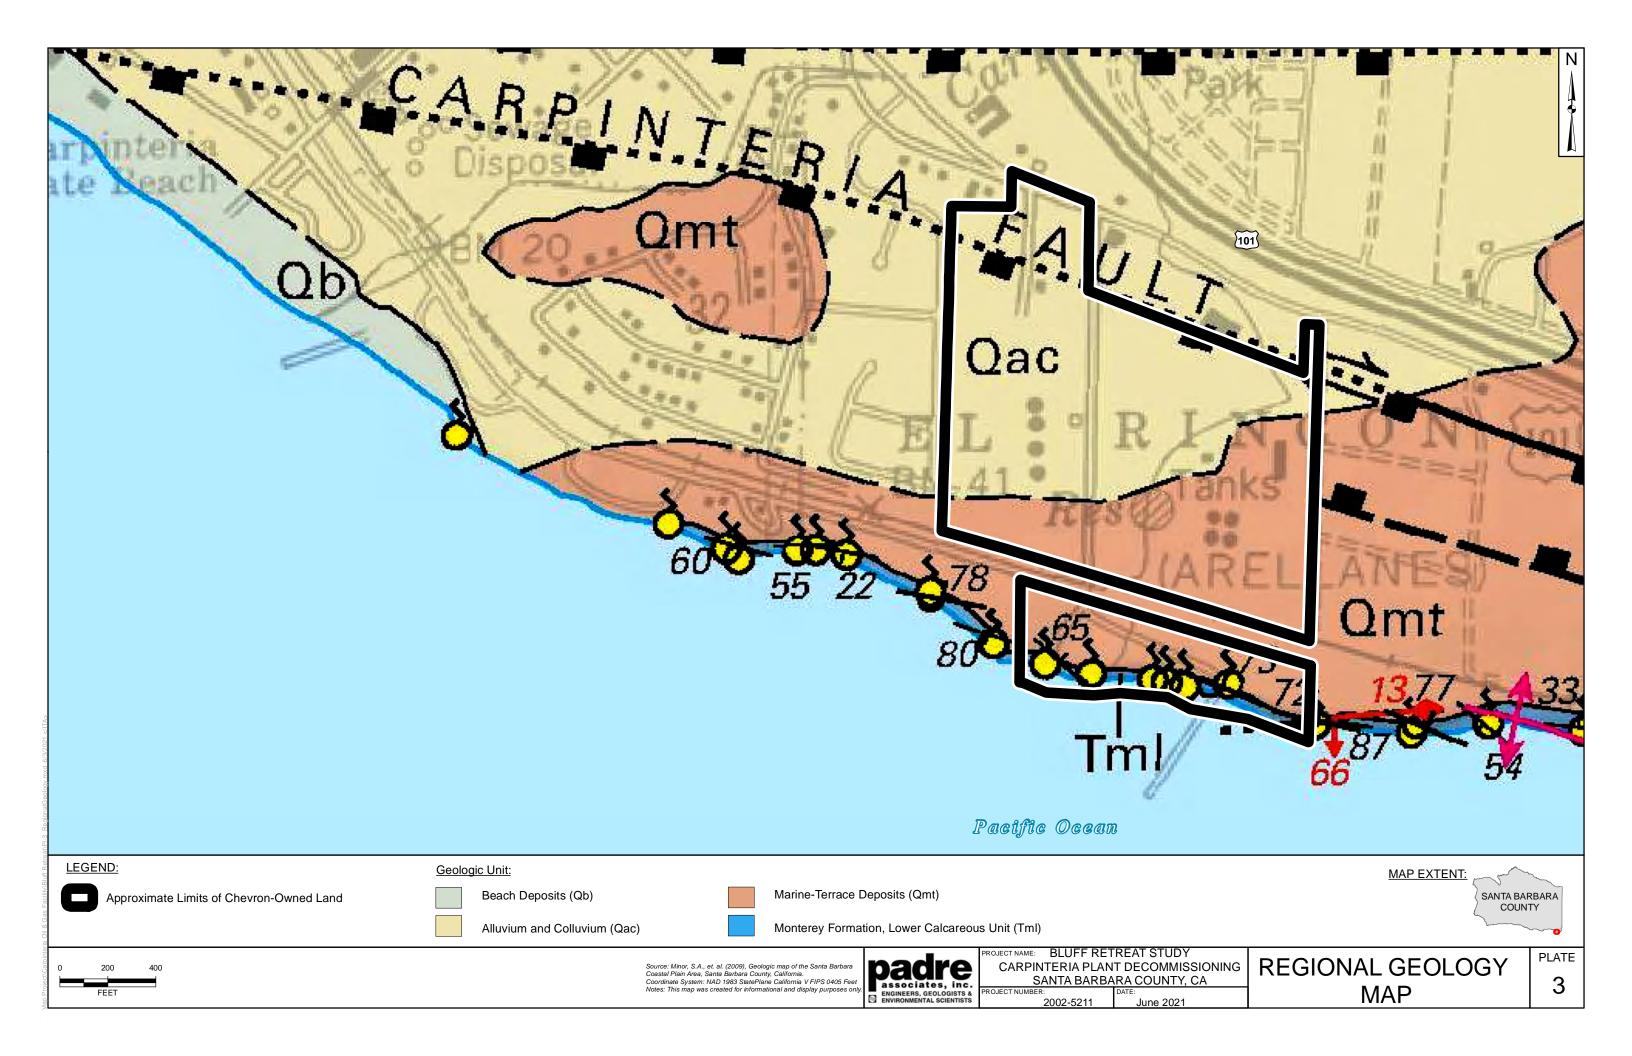
The Project Site is located along the south margin of the Transverse Ranges Geomorphic Province. These mountains represent a large east-west-trending anticline that has been complexly faulted. The Santa Ynez Mountains and adjacent coastal lowlands, on which the Project Site is situated, are composed of sedimentary rocks ranging in age from Eocene to Holocene (Geotechnical Consultants, 1976; Plate 3).

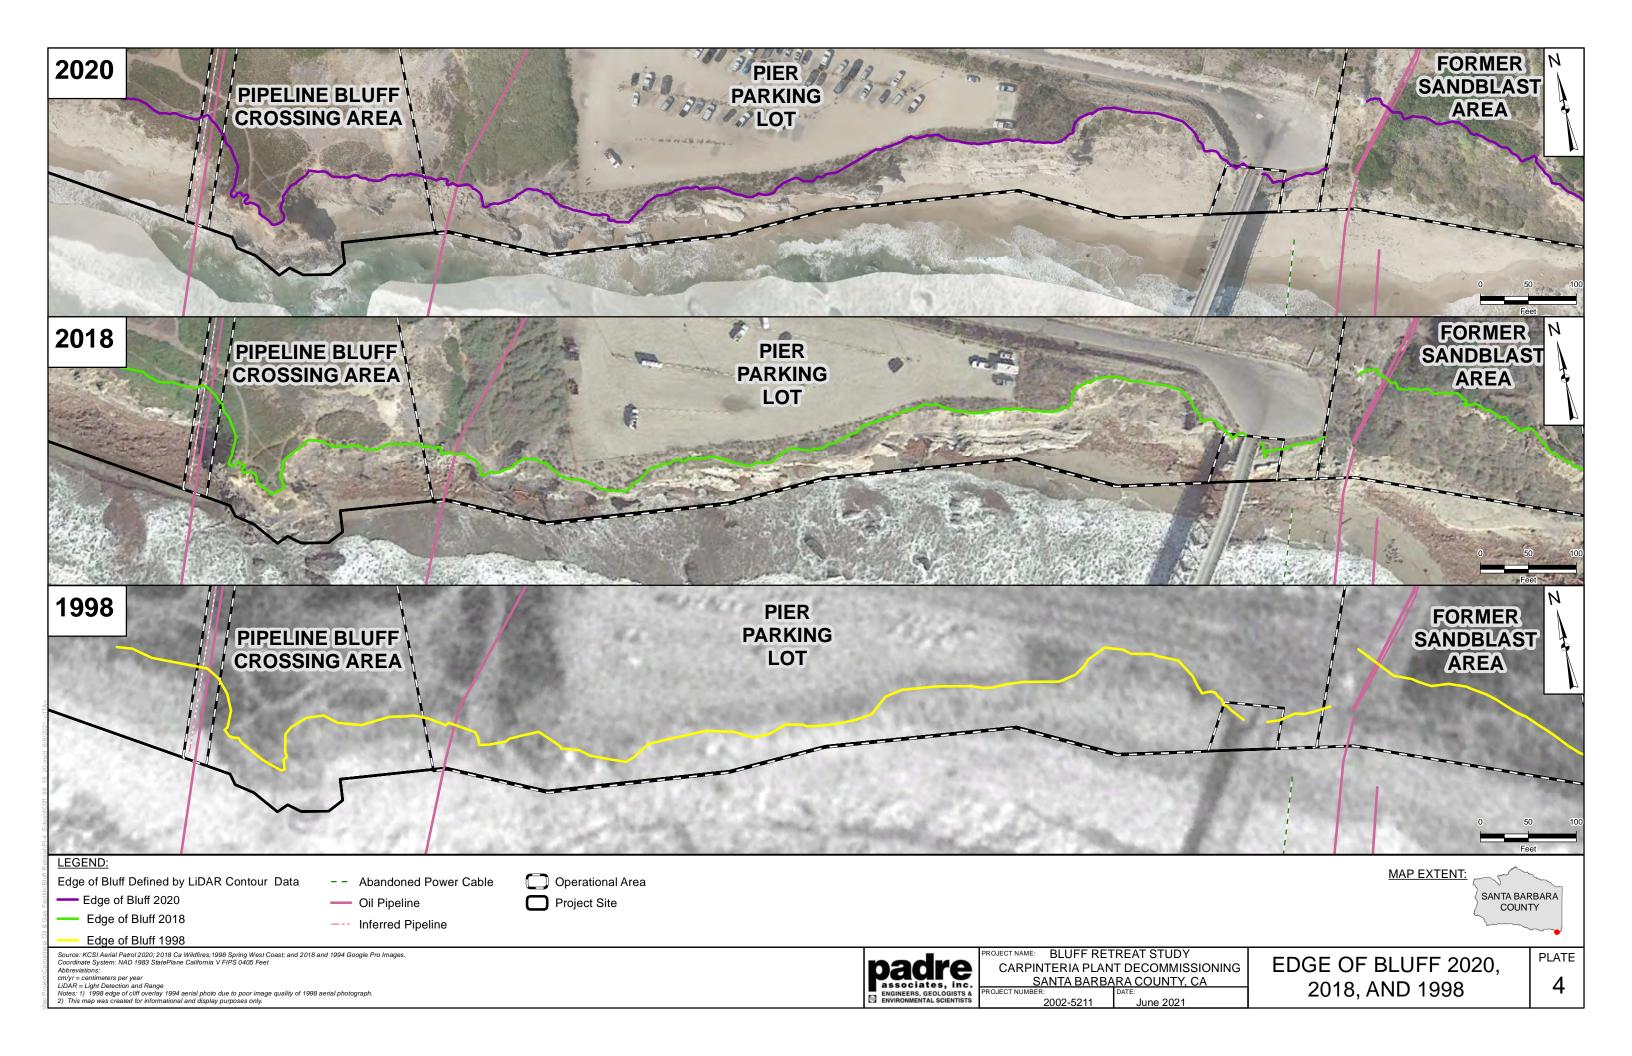
LiDAR elevation data was obtained for the years of 2020, 2018, and 1998 (Table 1). The LiDAR data was collected via aircraft using laser scanning technology to capture coordinate location data as northing, easting, and elevation data as a point cloud. The point cloud data was interpolated by the data collection agencies and provided to Padre as polyline feature contour data delineating the sea-cliff at the Project Site. The edge of sea-cliff was delineated in geographic information systems (GIS) from the contour LiDAR data for each data set: 2020; 2018; and 1998 (Plate 4).

Historical aerial photographs corresponding to the years of LiDAR data were used to fine tune the delineation of the top edge of the coastal bluff (Table 2). Aerial photographs were viewed in two-dimension (2D or planar view) and in three-dimension (3D) in ArcMap and Google Earth Pro, respectively. It should be noted that a 1998 aerial photograph of sufficient quality for analysis was unavailable for use at the time of this study; however, a 1994 aerial photograph was available from Google Earth Pro that generally agreed with the 1998 edge of coastal bluff and was used as background imagery for display purposes (Plate 4).

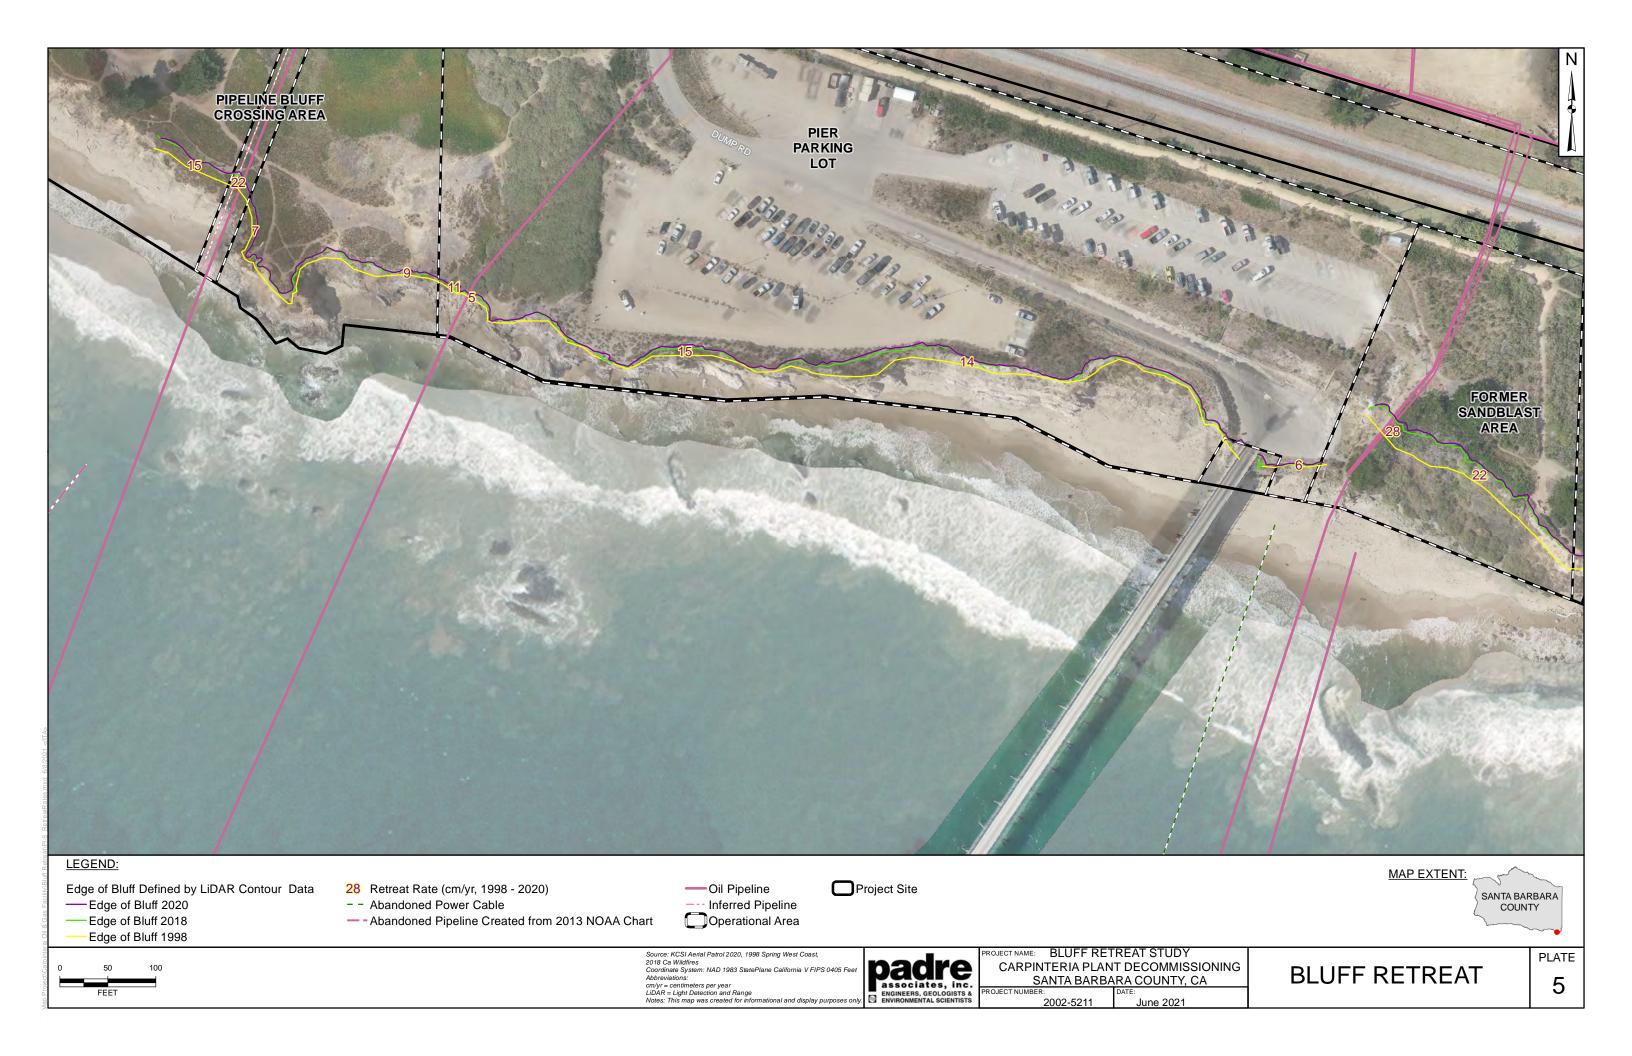
Annual retreat rates for the edge of the coastal bluff at the Project Site were estimated at eleven points that were selected based on proximity to the proposed pipeline landfall removal locations (Plate 5). Additionally, retreat rates were estimated at locations between the pipeline

landfall locations where significant retreat was evidenced by the historical LiDAR data and aerial photographs. Estimated annual retreat rates shown on Plate 5 were calculated using the change in distance of the 2020 and 1998 LiDAR defined edge of bluff divided by the 22 years separating the collection of the data sets. An estimated average annual retreat rate of 14 centimeters per year (cm/yr) for the Project Site was calculated based upon the average of the eleven point specific retreat rates displayed on Plate 5.

Additional factors such as aspect, tidal influence, and rock strength also contribute to the range of estimated retreat rates at the Project Site: 6 to 28 cm/yr (Plate 5). The retreat rates at the lower end of the range are found at locations where the bluff has been armored at the toe with riprap (large boulders) or the bluff top edge of cliff was reinforced with a concrete pad. In general, higher rates of retreat were associated with sections of the bluff with a western aspect.

An estimated average annual retreat rate of 14 cm/yr was calculated for the Project Site from a comparison of 2020 versus (vs.) 1998 LiDAR data. In 2013, a University of California, Santa Barbara Master of Science Thesis, *Using Laser Scanning Technology to Monitor Coastal Erosion and Sea-Cliff Retreat in Southern Santa Barbara County, California*, estimated regional erosion rates for the stretch of bluff in the vicinity of Tar Pits Park, the Carpinteria Pier, and the Carpinteria Bluffs Nature Preserve to be approximately 11 cm/yr. The 2013 study calculated estimated annual erosion rates using 2010 vs. 1998 and 1997 NOAA LiDAR data. The 1998 NOAA LiDAR data set used in the 2013 study is the same elevation data set that was used in the current study conducted by Padre (von Thury, 2013). The retreat rates estimated for both this study and the von Thury 2013 study generally agree with a 2005 study by Gary Griggs et al that calculated retreat rates based on monument measurements at various locations in southern Santa Barbara County between Point Conception and Rincon Point to range from 8 to 30 cm/yr.
